The status of biological invasions of the Bot River estuary and immediate environs. M N Austin, April 2019. Botfriends, Fisherhaven, South Africa.

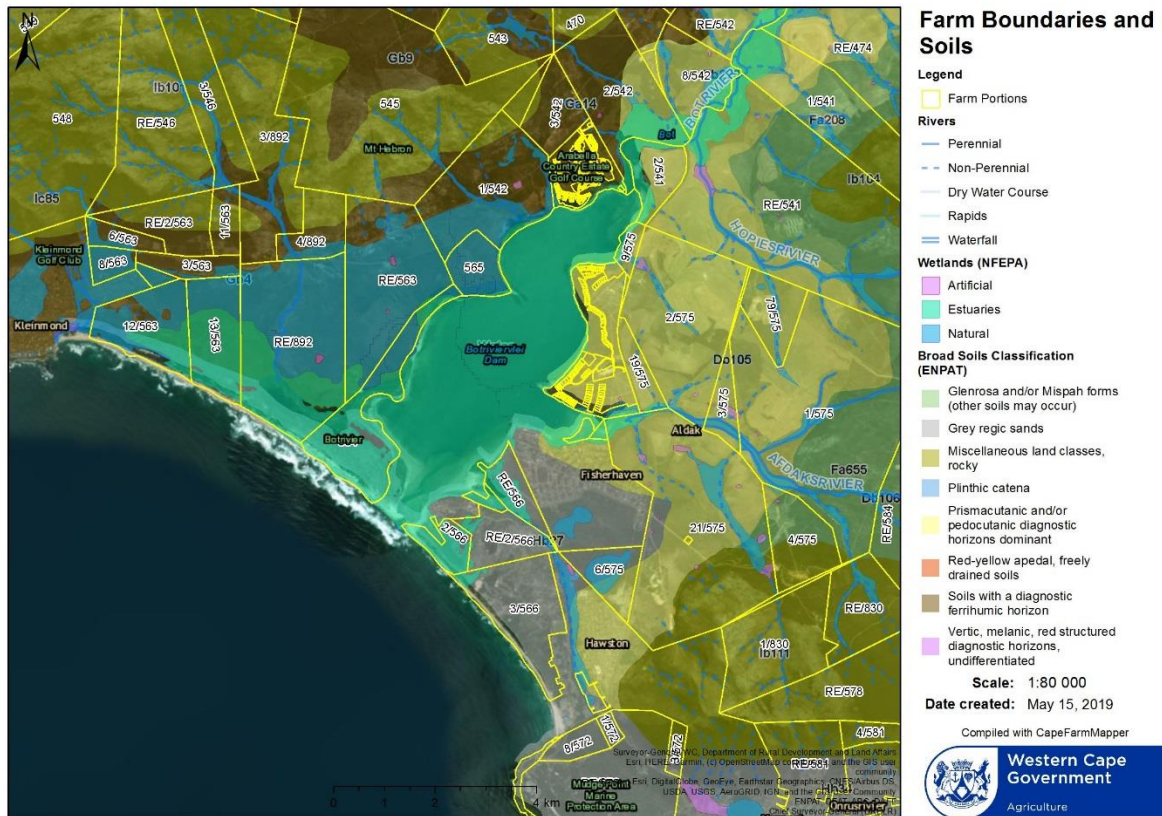
Figure 2 Soil types and existing farm boundaries surrounding the Bot River Estuary

Most of this area consists of soils with a diagnostic ferrihumic horizon (Fig. 2). In the southern area they tend to be shallow with colluvial and alluvial sand, capable of growing shortish fynbos, classified as Gb 4 (Appendix 1). Close to the estuary and along the sea are grey regic sands, fairly undifferentiated and more prone to invasive species without careful management, classified as Hb 27. The area around Arabella and stretching north from Arabella are deeper soils with a higher production potential, classified as Ga 14. Generally this area gets significantly more rainfall than the eastern side of the estuary, because of its proximity to the mountains. It has developed deeper soils, with a higher clay content, with better water-holding capacity and better nutrient status and is therefore capable of much better vegetation production of fynbos, with greater species diversity. However, these conditions lead to greater growth production of invasive species.
