Paddavlei Ecosystem Rehabilitation

Preliminary draft

Paddavlei ecosystem rehabilitation

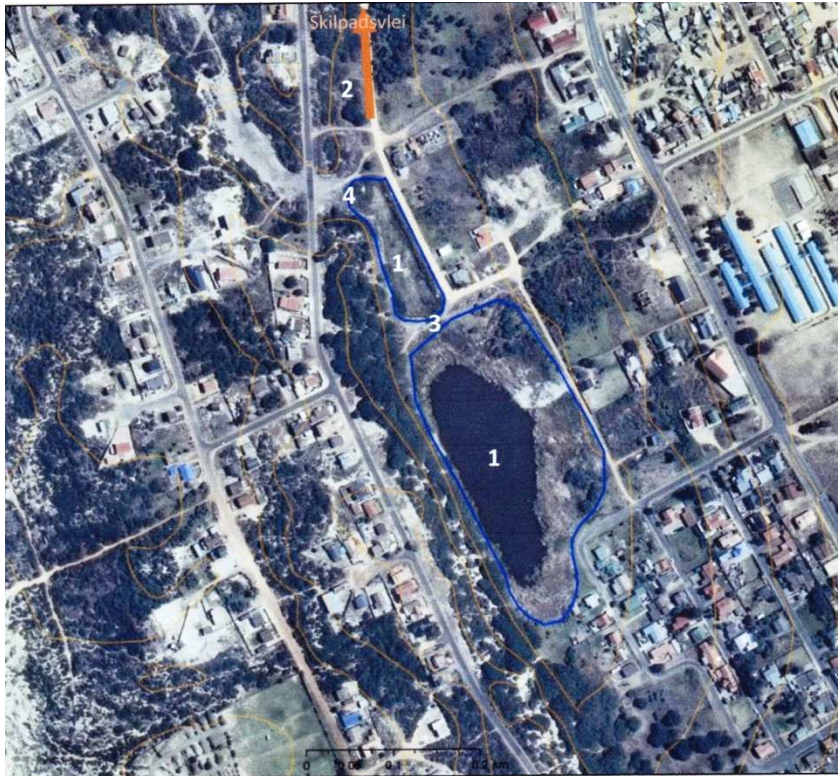
Map 1: Paddavlei circa 2008, showing a large body of water with minimal reed growth

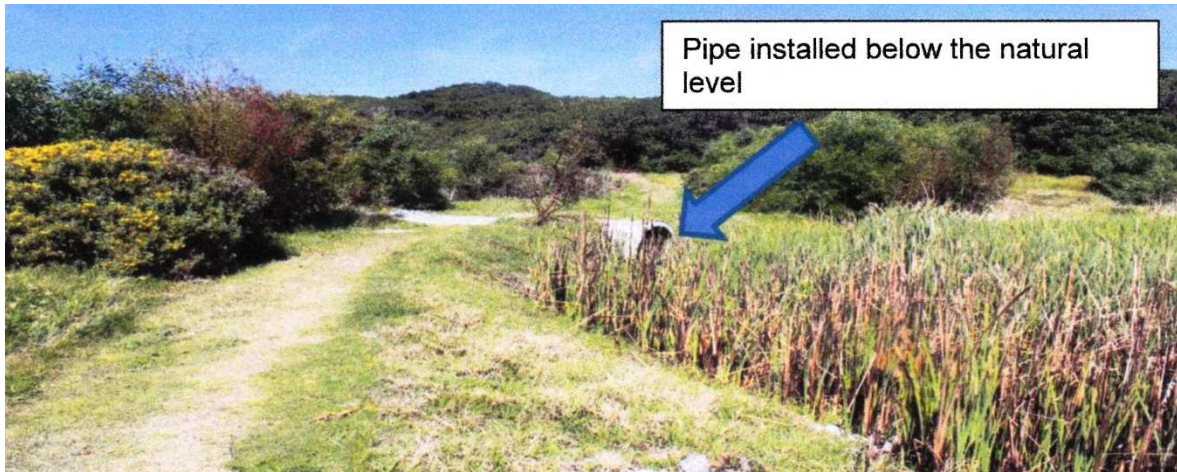
Picture 1: Entry to the pipeline to drain Paddavlei

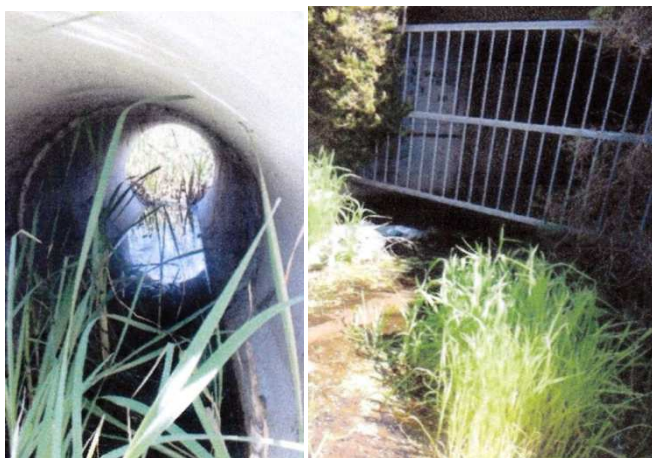
Picture 2: Close up of pipeline entry and the pipeline draining water from the Paddavlei

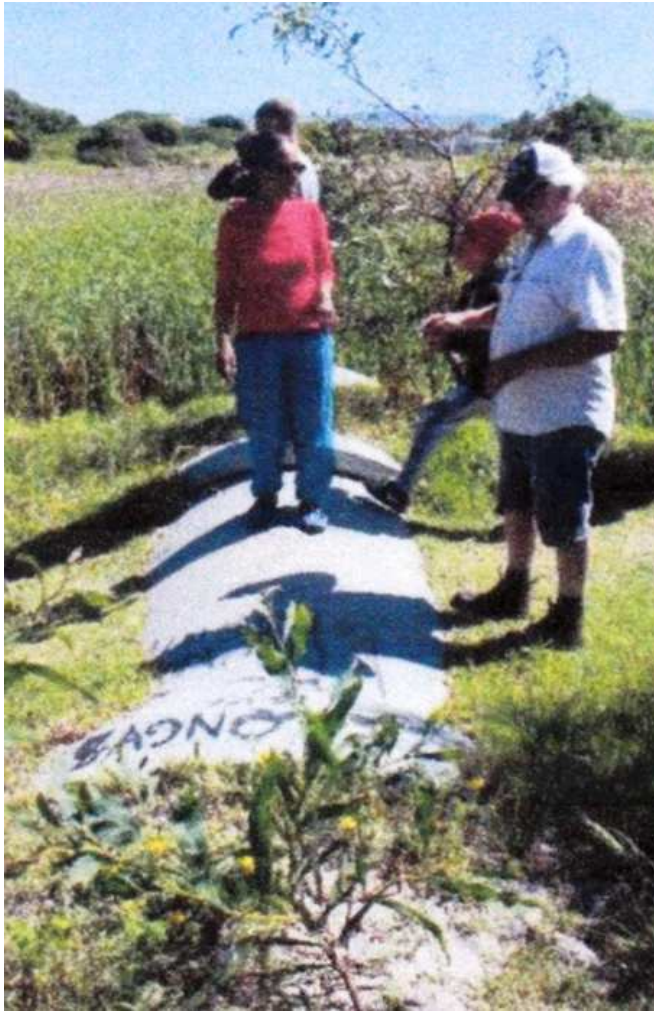
Picture 3: Roadway constructed across the vlei, which is now just a footpath.

higher ground to the east. It is still a wetland area covered in reeds. A recent dirt road which has deteriorated to a footpath crosses this area in an east-west direction.

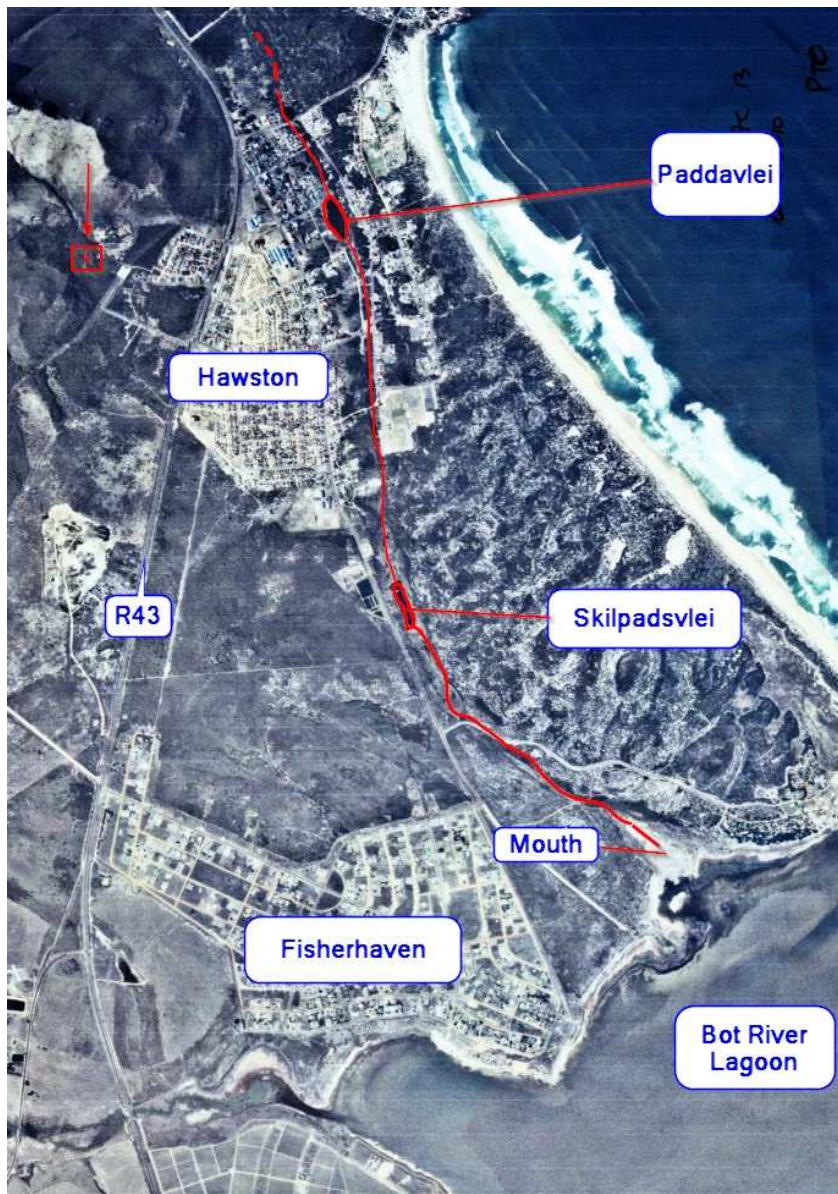
Map 2: Showing the general layout from Hoek van die Berg to Bot River Lagoon with Paddavlei and Skilpadsvlei.

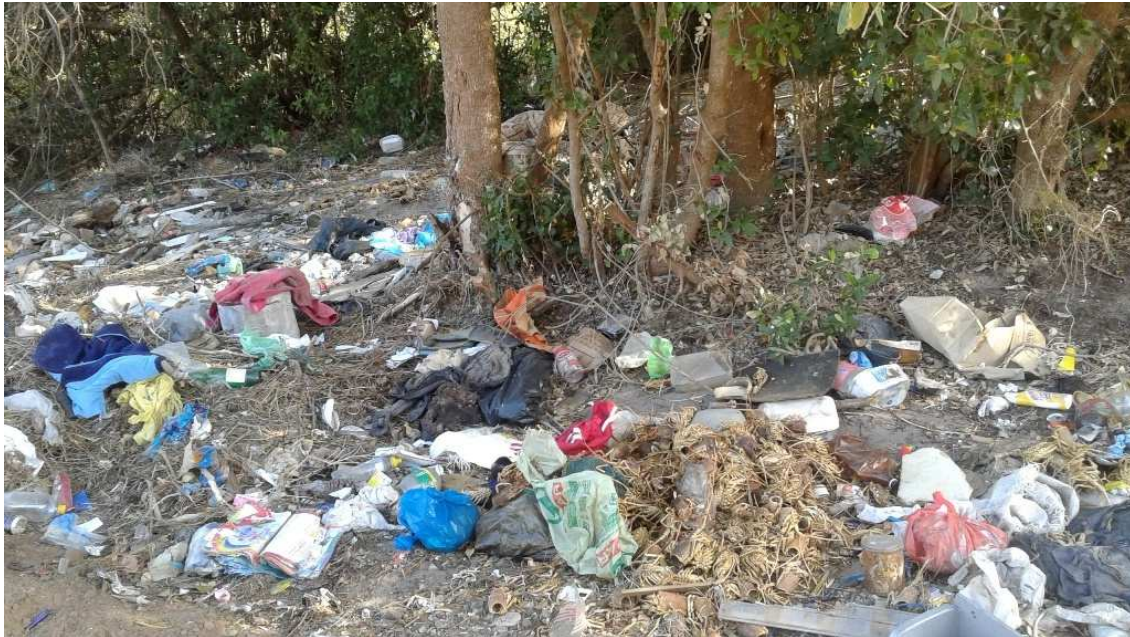
Picture 4: Rubble and waste dumped into the wetland.

The Paddavlei has for decades been used as a dumping ground. Very little evidence exists that any attention has been given to preserving it as a wetland. The Paddavlei itself, the wetland area extending to the Skilpadsvlei, Skilpadsvlei itself and the area extending to the Bot River Lagoon have not been declared green areas. Rubble, storm water, sewage leaks, roads and even houses have been built within the wetland area.

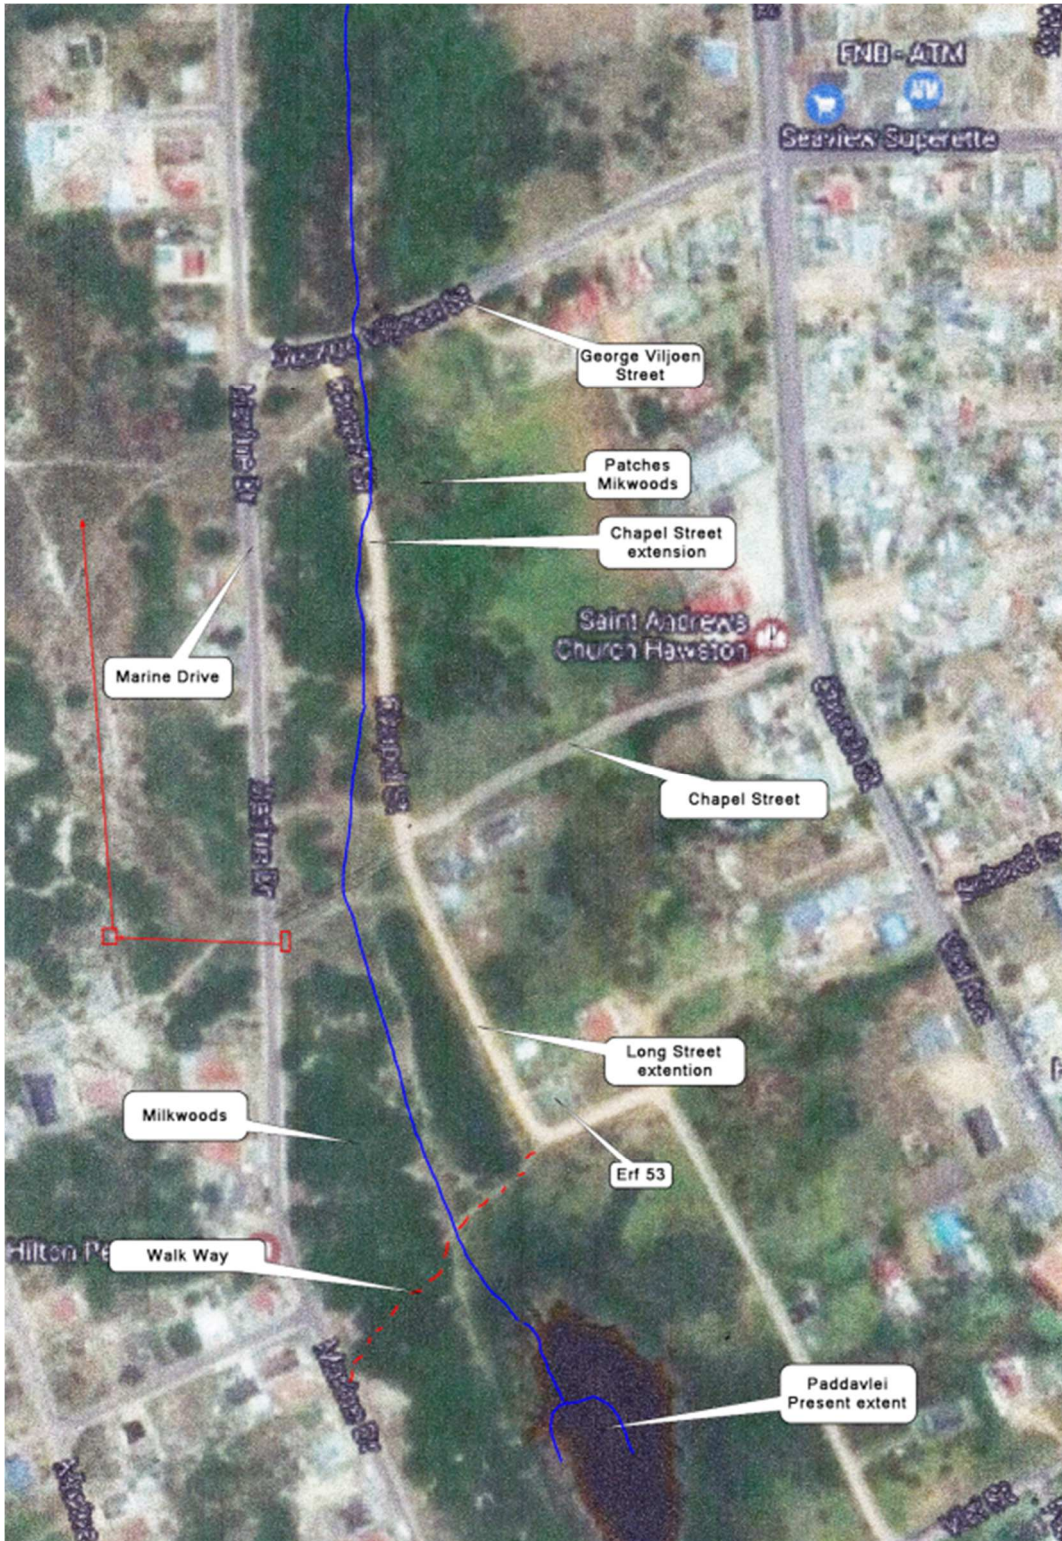
Map 6: Satellite image showing the vegetation as it was in 2010 with the original river course and the pipeline drain installed in 2008.

water storage reservoir (Vivier 2007). The major problem may be increased seepage, where the pipeline was dug through the dune and the relatively impervious layer below the sand was cut through to instal the pipeline. This may need some remedial action to save the Milkwoods at the bottom end of the Milkwood forest, ***which are showing signs of stress.***

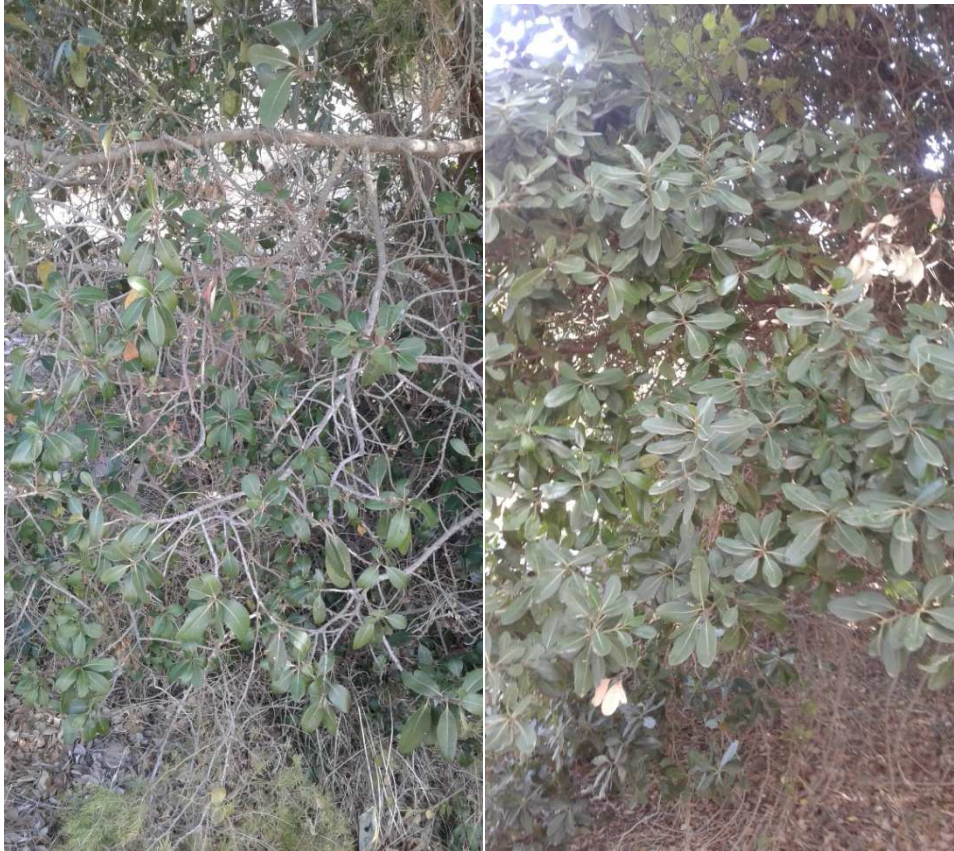
Picture 5: Stressed Milkwoods versus healthy Milkwoods

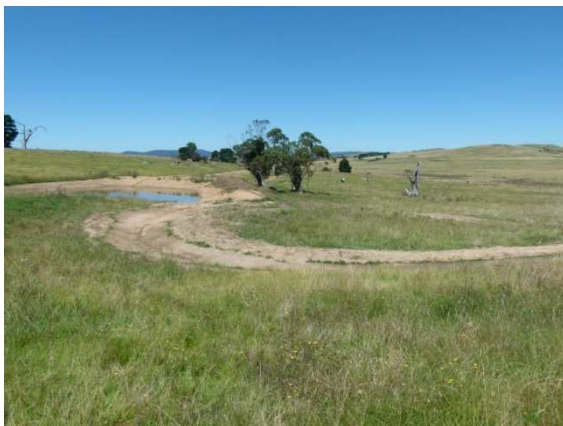
Picture 6: An example of the open water channel

Short sedge grasses can be planted in the wide open channel. This will allow storm water to flow easily through this section. The growth of trees or shrubs should be limited and controlled in order to keep it clear for storm water. The idea is to keep it natural-looking and seemingly part of the natural landscape: it should not be in a perfectly straight line.

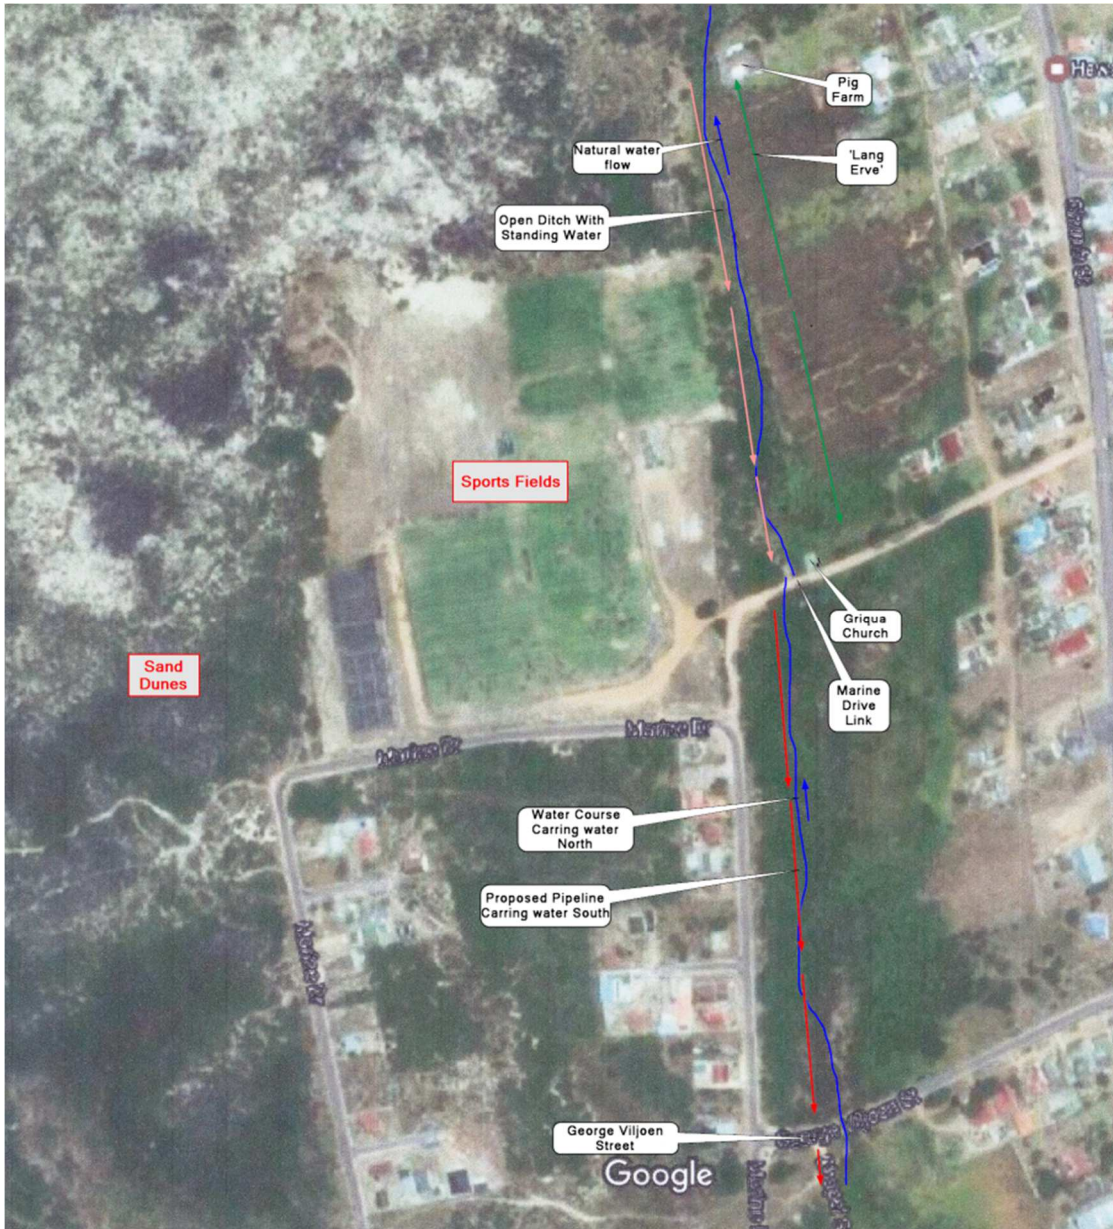
Map 8: Satellite image showing the natural course of the river with extensive exotic tree growth with some Milkwoods

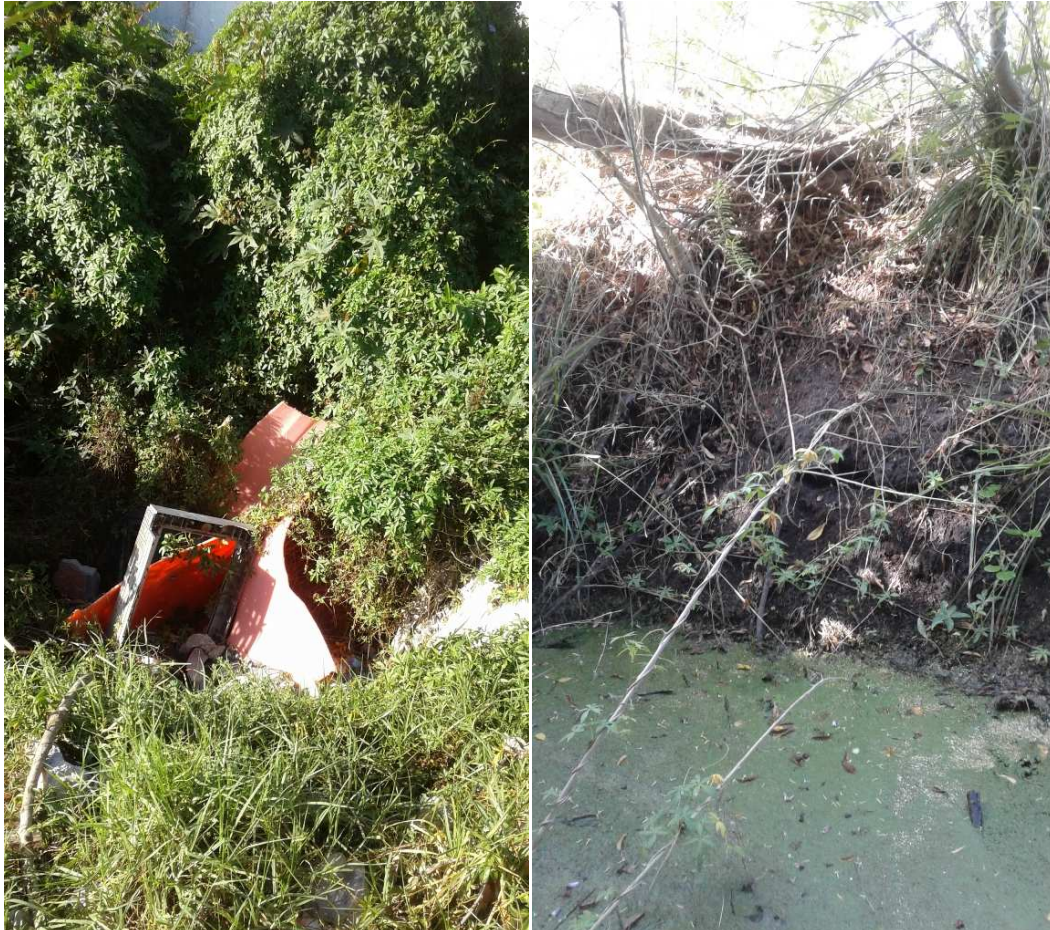
Picture 7: Open ditch, south end 3.5m deep and north end 1.5m deep

This is blocked at the pig farm end and results in storm water being accumulated in the ditch and seeping sideways, mainly to the east into the 'Lang Erwe'. The ditch still has standing water at the end of the dry summer in April.

The damming of water in the ditch has resulted in more reed growth on the 'Lang Erwe'. One of the owners of a plot, whose father used to cultivate his plot, now finds it too wet to use for vegetable production. It would appear that this area was relatively dry on the surface but had a reasonably high permanent water table. Parts of this area have extensive invasion of Port Jackson, with young trees with stem diameters of 20-30mm, standing as high as 12 metres. Obviously this is very fertile ground, with good water, capable of growing just about anything adapted to the area.

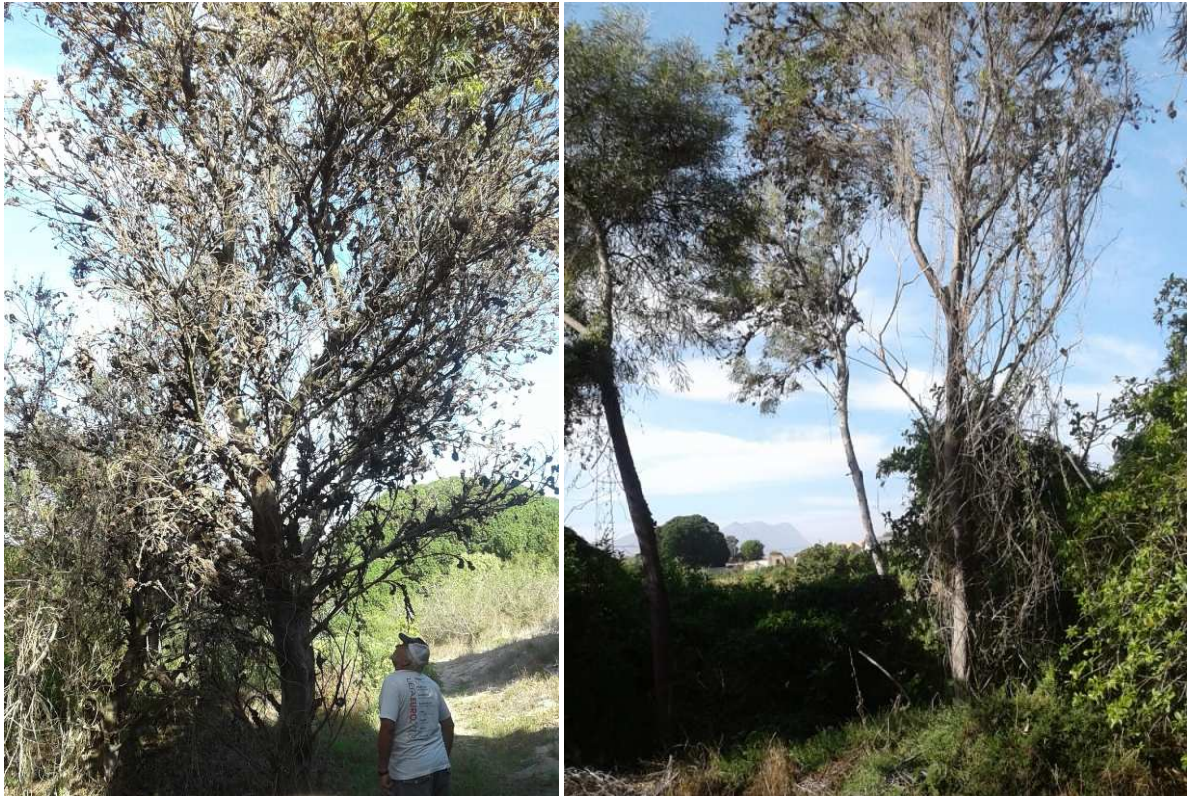
Picture 8: Large Port Jackson trees

A number of hand-dug wells were evident in this area, some dug to considerable depth, and were used for supplementary irrigation on the agricultural plots.

The earth works done here need to be filled in and the gentle run of storm water to its original flow through this area to be re-established. This will help to drain this area of excess water and re-establish the water flowing into the Skilpadsvlei. The damage done to the sub-surface flow of water may never fully recover, but it is hoped that this will start functioning in the same way that it used to with time. It will have to be monitored and maybe future adjustments will need to be made. The blocking of the normal flow needs to be investigated once the area is cleared, to be sure that it will not continue to hinder both storm water flow and seepage flow.

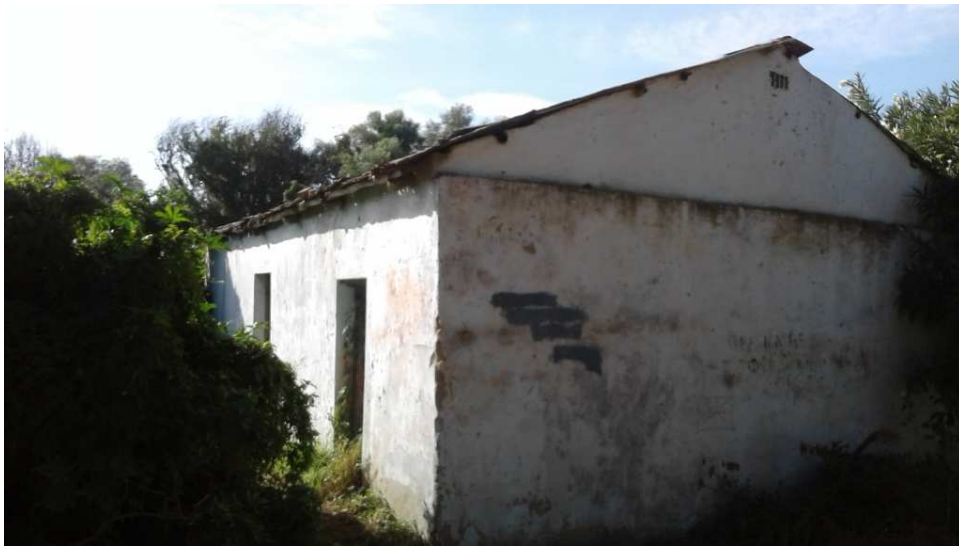
Picture 9: Griqua Church

The old Griqua church below George Viljoen was built on dry ground but had lots of sub surface water: essentially a wetland without surface water. Storm water had not caused damage in the past. However, the work done on George Viljoen and the earth works done in 2007 have increased the risks of water damage. This is a national monument and any work done in the area needs to protect this church.

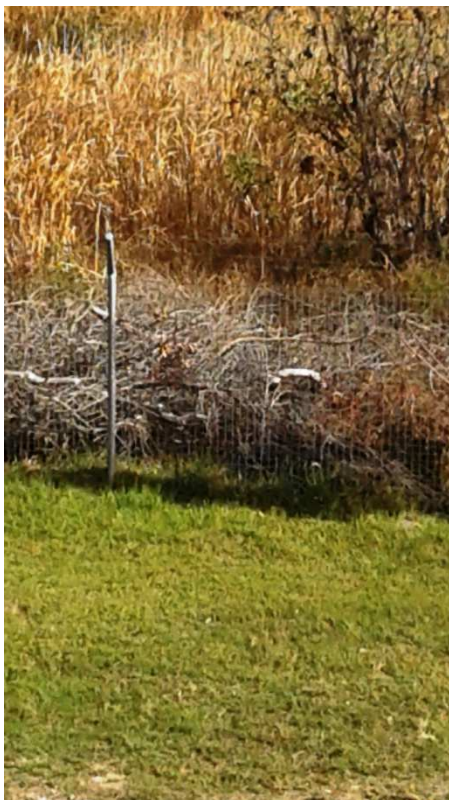
The sewage farm facility feeds water across the road directly into the wetland area of Skilpadsvlei. This is not always clean water, and it has a high nutrient load. (Note the prolific growth of the reeds in the wetland area of Skilpadsvlei.)

Massive growth reeds

It should be rather released north from the sewage farm, preferably spread over a relatively large area which could be growing some crop of value, where the soil/sand could further reduce the nutrient load before it seeps back into the natural drainage area below the Skilpadsvlei where it will get further cleaned before finally entering the Bot River Lagoon.

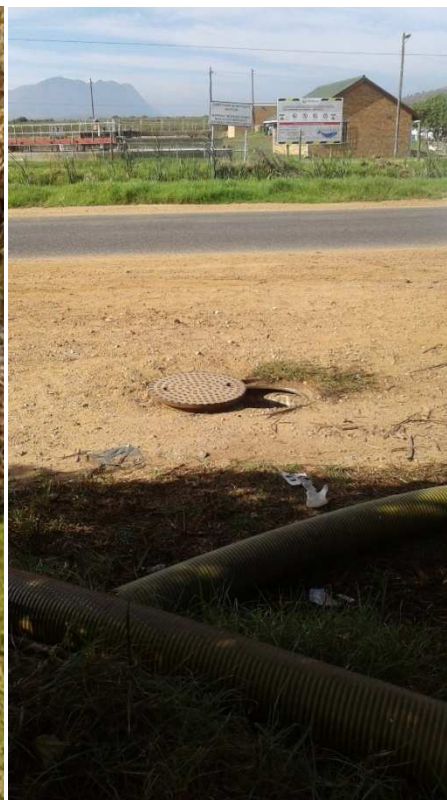
Sewer from Wetland side

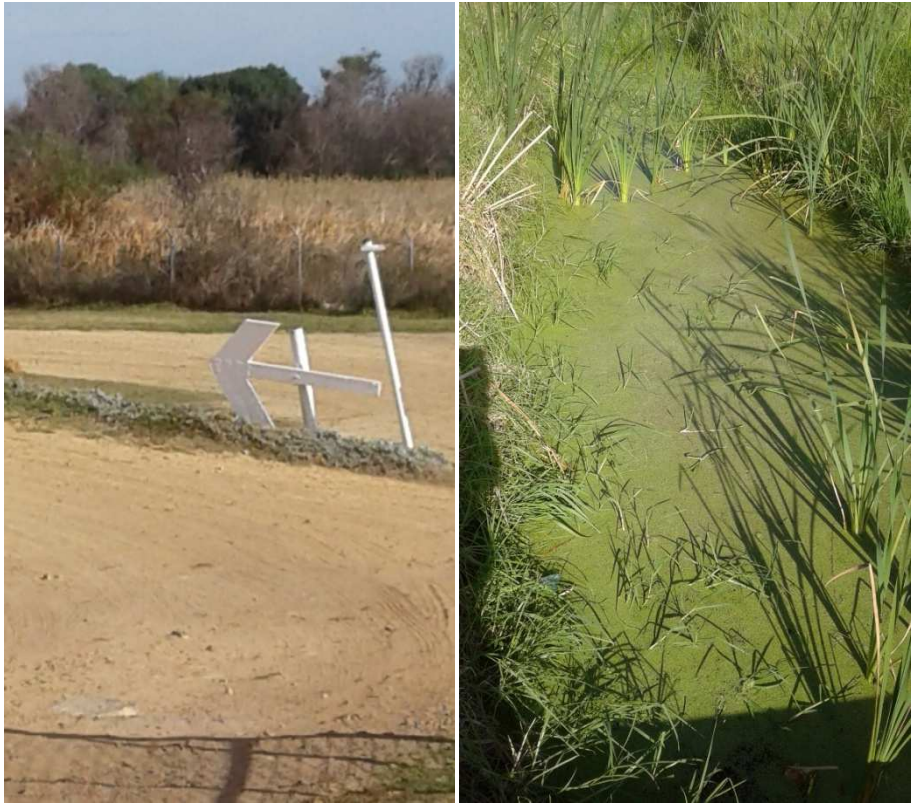
Rubbish tip site pushed into wetland

Algae growth on water entering Skilpadsvlei

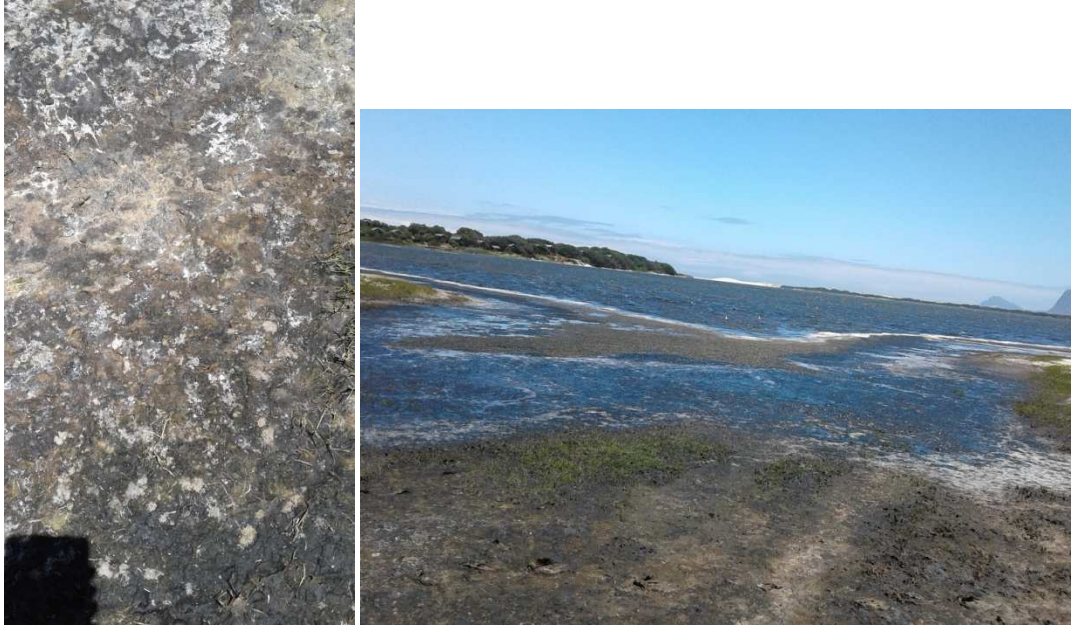
Picture 11: Close up and general view of pollution from the dump site

The road just before Fisherhaven leads to an old dump site bordering on the Bot River Lagoon. This is a very poor area for any sort of dumping as waste can very easily enter the Bot River Lagoon directly. At the time of the Fisherhaven festival in 2017, the toilets on the way to the festival were observed dumping sewage at the site. Other toxins were observed on the site and the general public and OSM were still dumping materials on the site. The picture shows pollution in the inlet to the site which is more than the normal growth of algae from receding water levels in the Bot River Lagoon.

It appears this dump site is been discontinued and some cleaning has occurred. However, the site has to be properly cleaned and the road has to be closed to avoid further pollution of the lagoon. The road has to be dismantled and the Fynbos be allowed to return to the road area, especially because of its very close proximity to the lagoon. It is suggested that this has to be done under the guidance of Cape Nature.

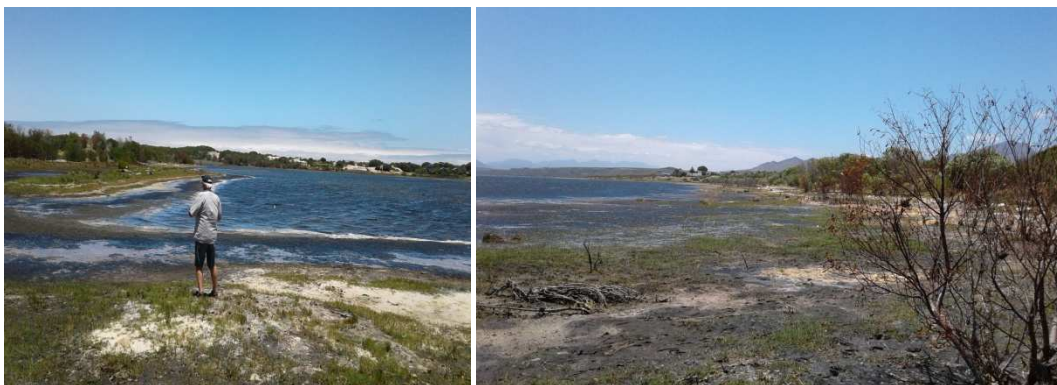
Picture 12: The inlet near the dump site and north of the inlet showing very little algae grow

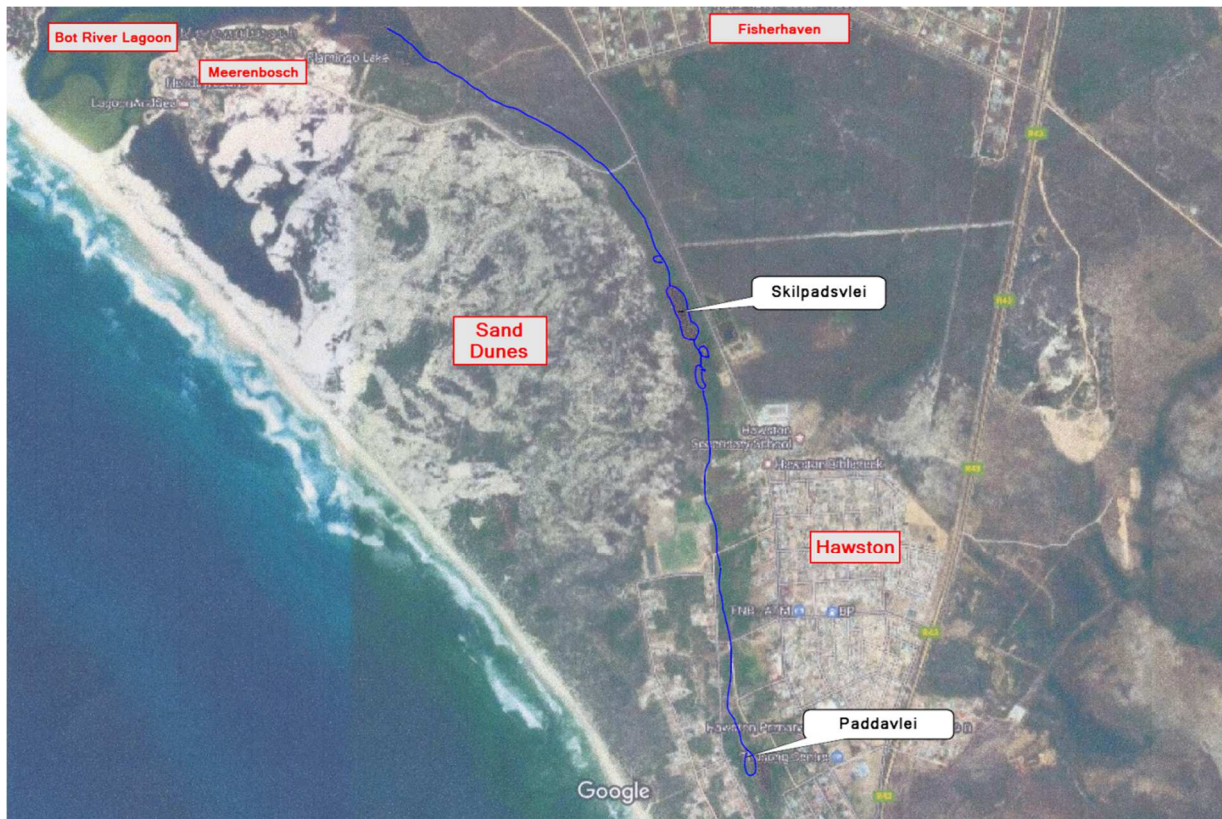
Map 10: Satellite image of the wetland area.

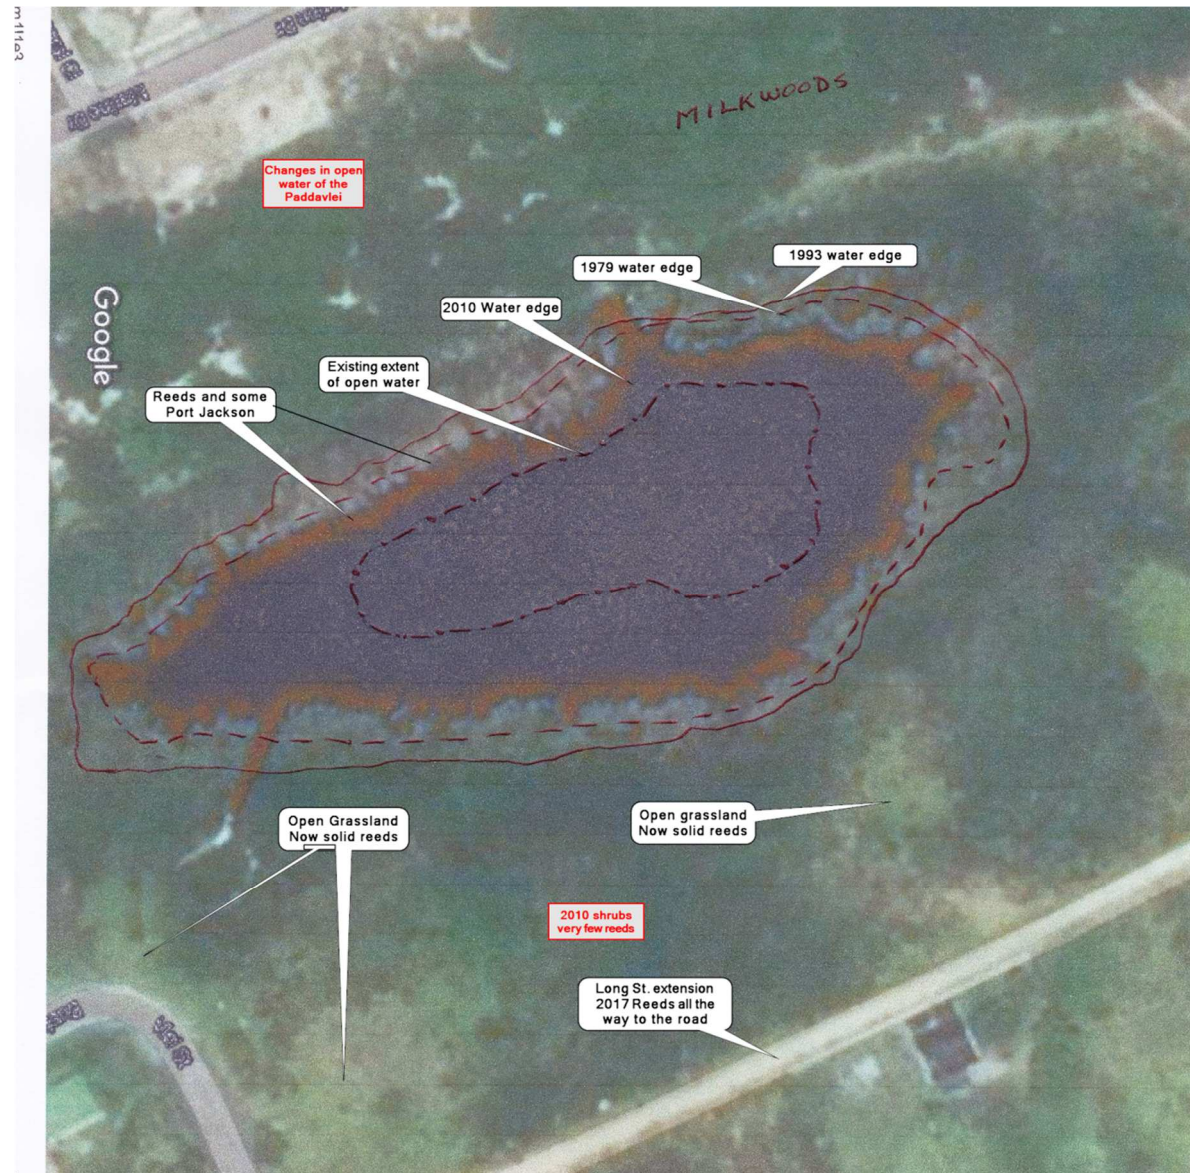
Map 11: The Paddavlei open water 2010 extent with the 1979 and 1993 water edge and the present extent of the open water, now surrounded by reeds

Around the open water the reeds (mainly bulrushes *Typha capensis*) have invaded into the shallow water to a very large extent on all sides and between the 1979 open water section and the present extent the reeds are growing in open water almost impossible to wade through. There are very few signs of any animals or birds and within the shallow water is a large volume of rotting vegetation, mostly reeds from previous years. This is adding large amounts of nutrients to the water which causes more vigorous growth of reeds further into

the water, compounding the problem of reed invasion. Within a year or two, at the present rate of invasion, there could be no open water left.

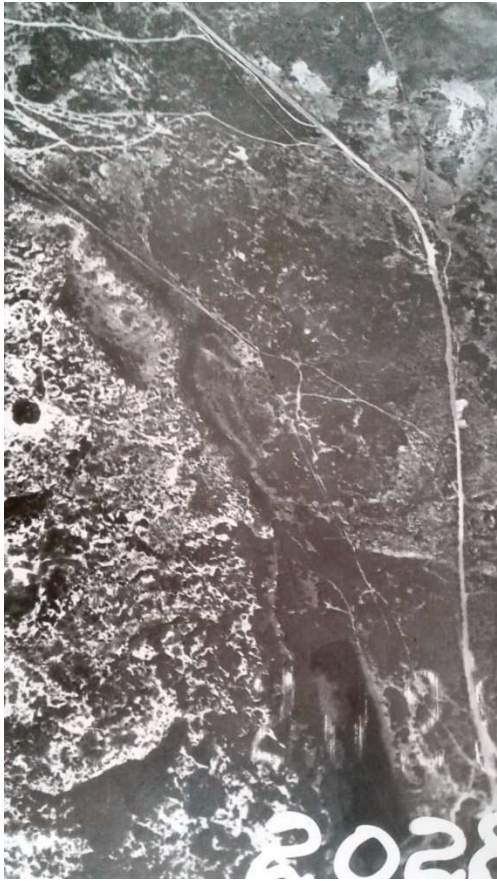
Map 12: Skilpadsvlei 1938 showing smaller main water body and large area to the north which had no reeds and would have experienced periodic flooding

The Skilpadsvlei open water body has been substantially reduced, especially in the last 7 years. With the increased normal water flow, much of the invaded reeds will tend to be drowned, adding a huge nutrient load of rotting vegetation which will be detrimental to the open water body. The reeds which have invaded into the traditional open water body area will be removed, re-opening the Skilpadsvlei to what it was 15 years ago, surrounded by reeds on all sides. Some Milkwoods can be re-established on the higher ground around Skilpadsvlei above the normal flood area.

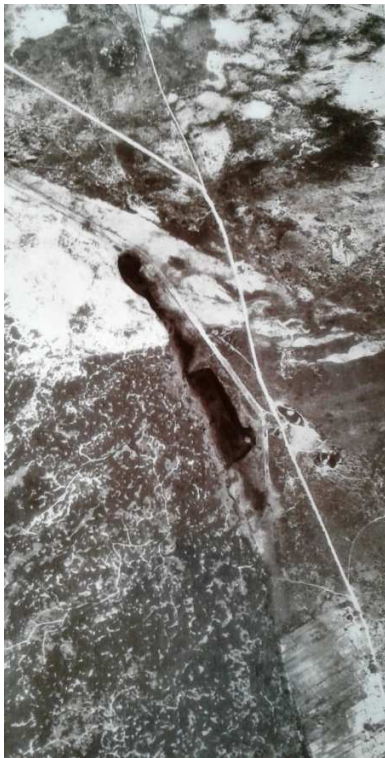
Map 13: Skilpadsvlei 1961 showing vastly extended water area to the north of the main body

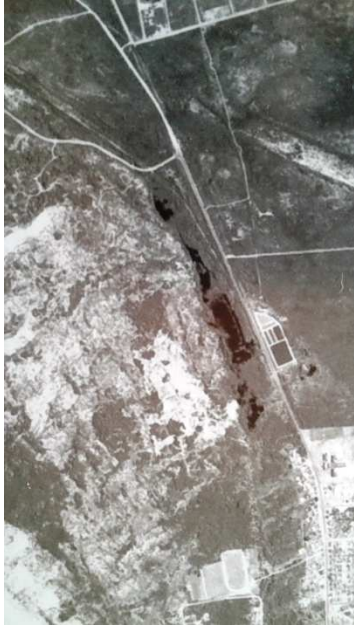
Map 14: Skilpadsvlei 1993 with main water body adjacent to the sewage farm and open water both north and south of the main body

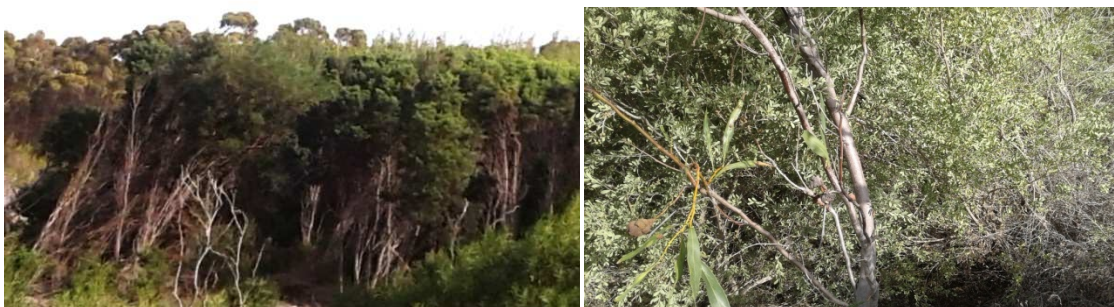
Primarily Port Jackson with Gum trees in the background Port Jackson, Myrtle and some pine
 Picture 13: Very densely invaded areas

One tool that we can use is fire for extremely dense stands of invaders, primarily Port Jackson, Myrtle and Pine. These dense areas are, in any case, extreme fire hazard areas. Immediate results of a burn are apparent: destruction of invasive species seeds, increases

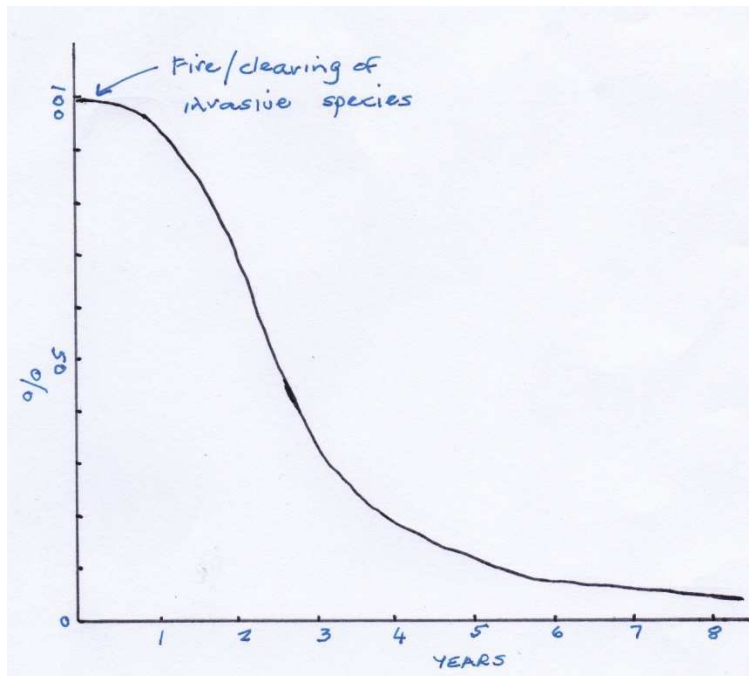
Figure 3: Reduction of seeds of a species in the soil profile over time, assuming no further input from nearby.

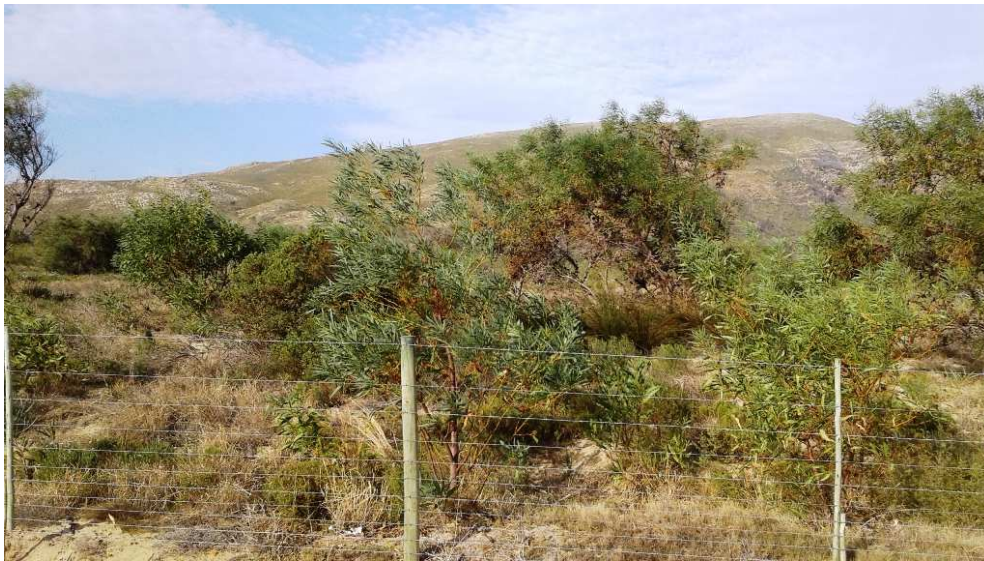
Picture 14: Less densely invaded areas

Management needs to remove the invasive species, preferably using pullers to remove the roots. Stumps should be cut and treated with poison immediately, with some ring barking which assists the effectiveness of the poison. We need, however, to limit the use of poisons as much as possible, especially because of their long residual effects.

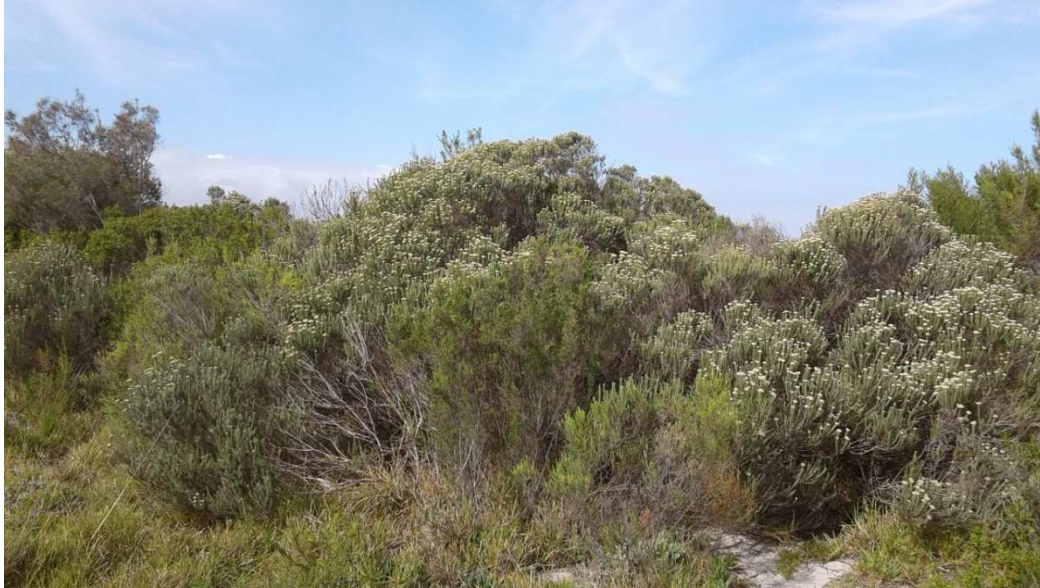
Picture 15: Good stand of Fynbos

Fires, which will probably occur more often than desired in this area, will be much less expensive to control and will cause much less damage to infrastructure. Control burns will be required in some areas to both maintain healthy Fynbos and a wide range of species. These can also be strategic to help reduce the spread of wild fires throughout the area.

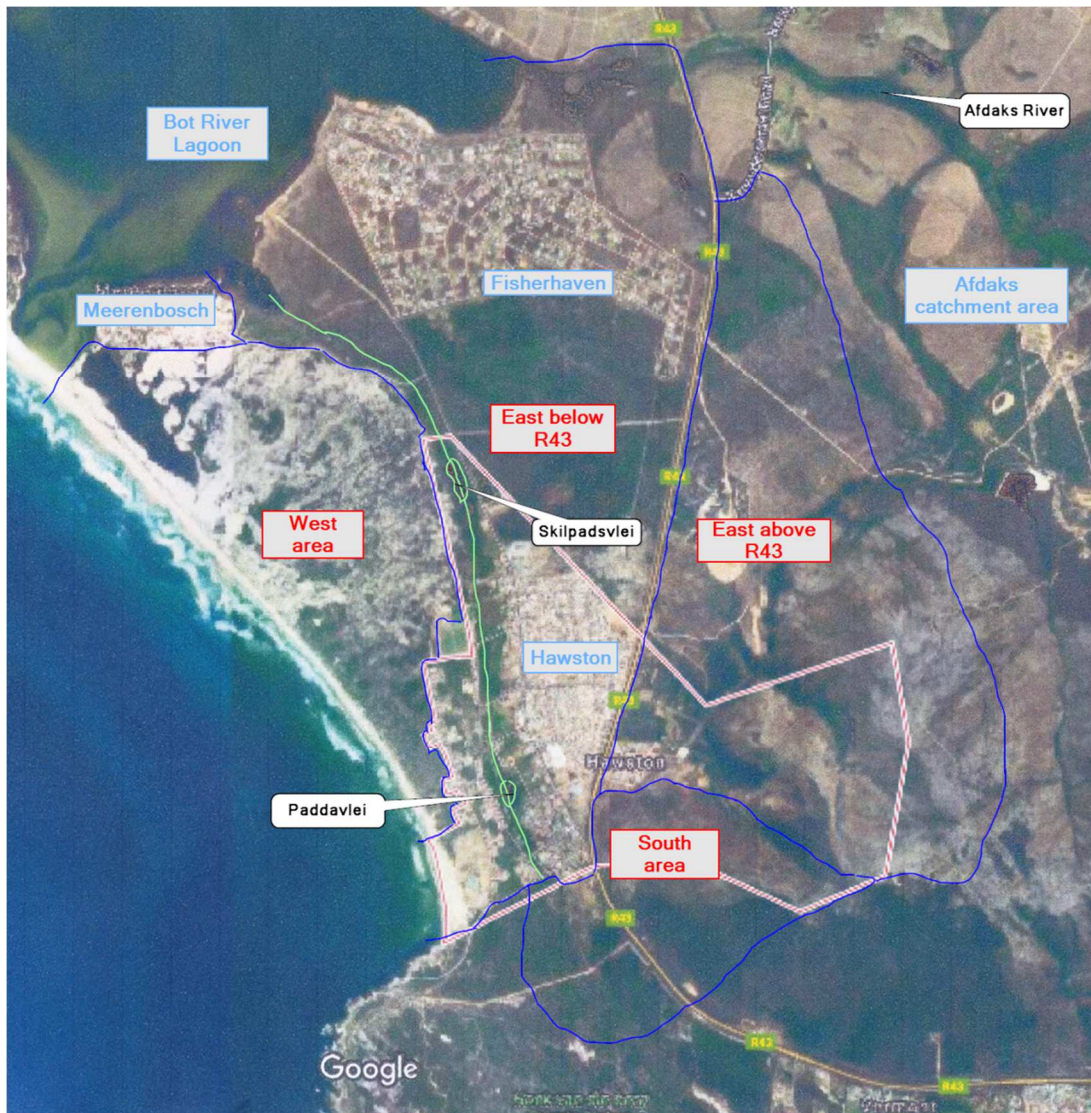
Map 15: The different management zones of the catchment area within the system

The area has being divided into four main management zones with different strategies applied within each management zone.

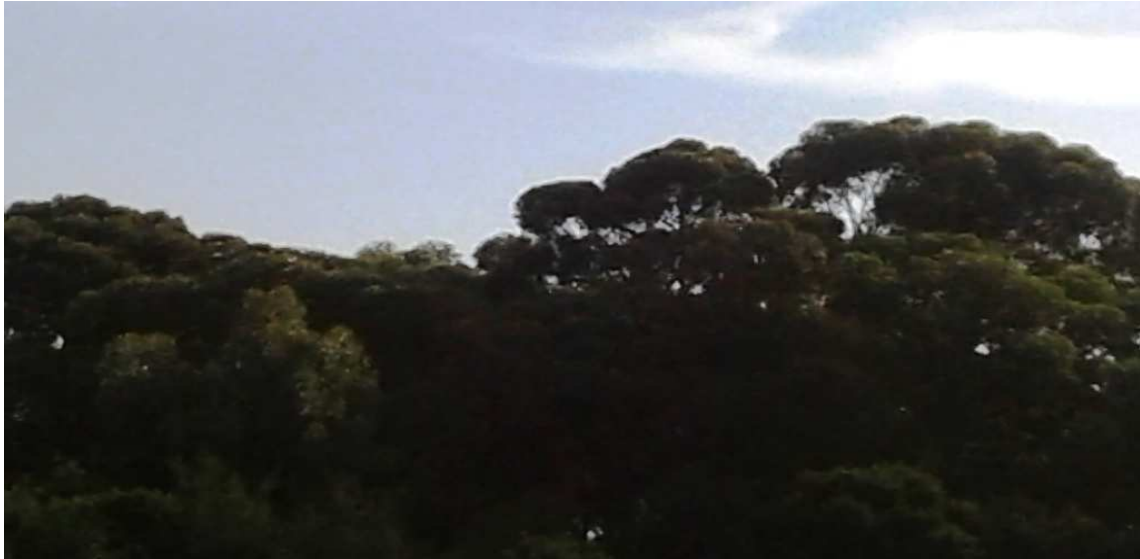
Picture 16: South of the Paddavlei, tall dense stands of Port Jackson with some Gums and Myrtle, mostly a closed canopy of invasive species (Area C10 on map 15).

been an option. This is a classic case of doing nothing because the problem became too big, which then compounds the problem. The fire load is continuing to increase every year, making it more difficult to sort out. We cannot afford to wait for a wild fire to solve the problem. It is imperative that we burn out this area under conditions of our choosing, as soon as possible.
