Paddavlei Ecosystem Rehabilitation

Preliminary draft

Paddavlei ecosystem rehabilitation

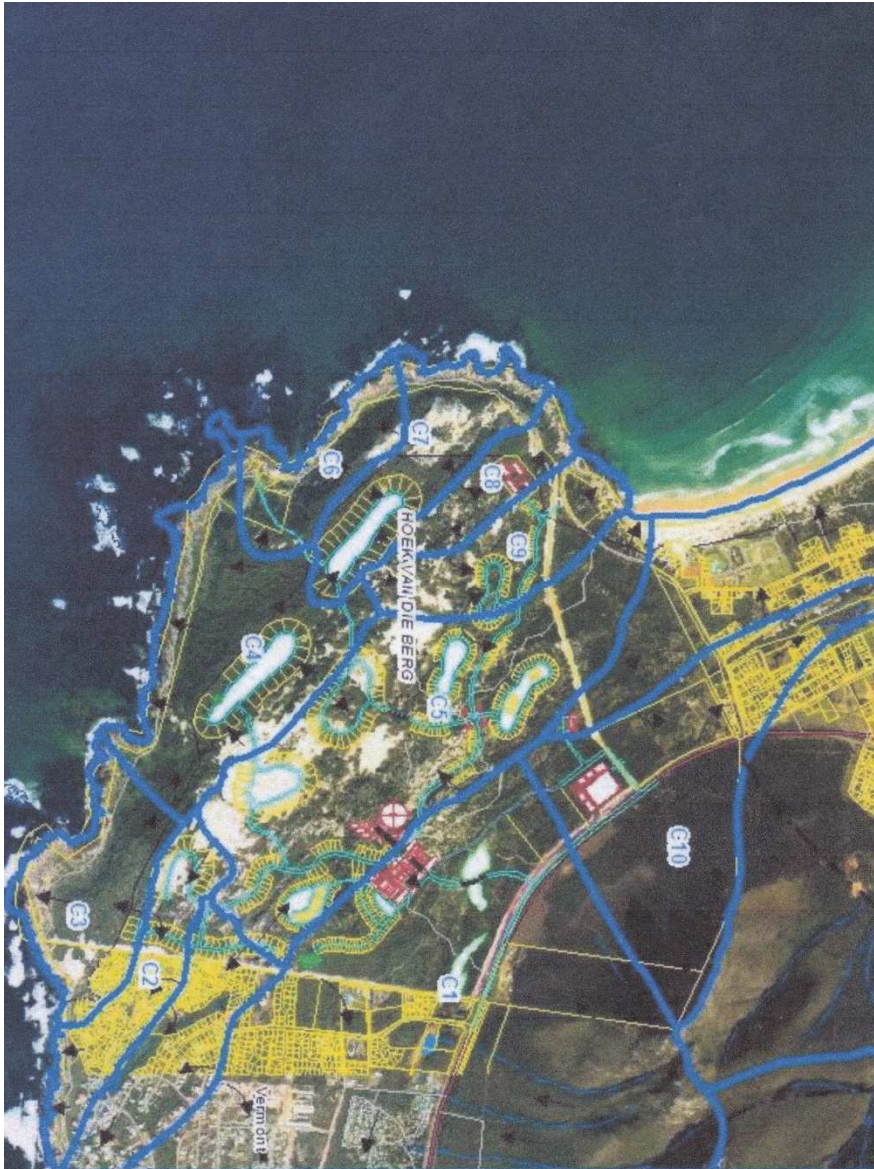
Map 16: Hoek van die Berg showing area C10 and adjacent areas on either side that drain into the Paddavlei (Kruger, 2015).

The area above the R43 is not severely invaded by exotics but needs to be also cleared of invasive species to increase seepage into the sandy lower lying area below the R43 which will increase seepage towards the Paddavlei.

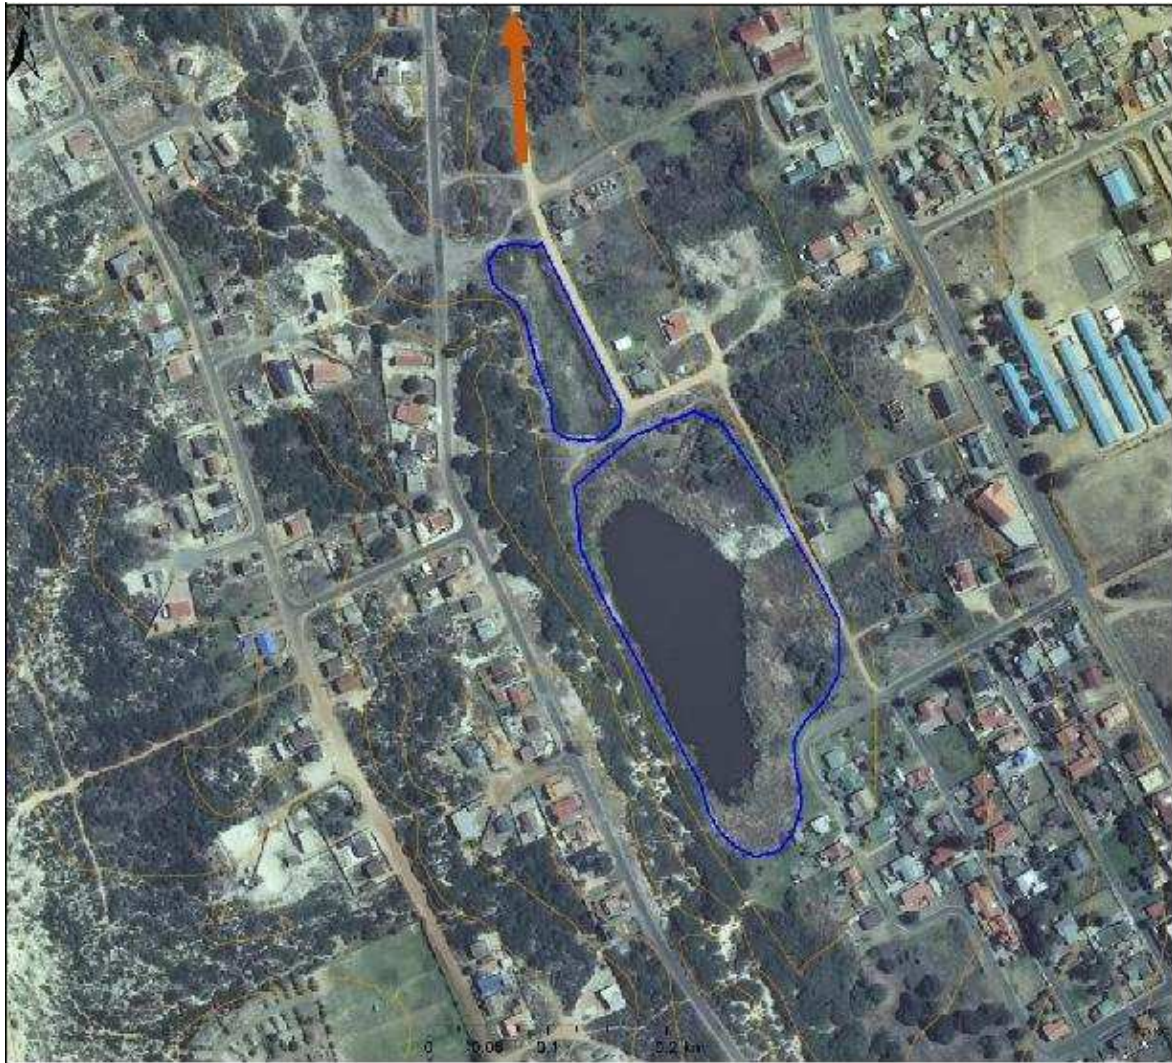
Figure 1. Map of Paddavlei with references in point form.

6. Earth berm splitting Paddavlei in two sections (point 3): The removal of the earth berm will require an Environmental authorisation. It is recommended that and a Professional wetland Ecologist and an Engineer assess the proposed rehabilitation intervention.

7. Culvert at lower end of Paddavlei (point 4): Consult the local Municipality on what the design rationale behind the culvert depth was. Should the raising of the culvert be supported by all parties it is recommended a survey be completed to establish the correct height based on calculated back flooding. Unfortunately the wetland is within a residential area and risks to flooding should be taken note of.

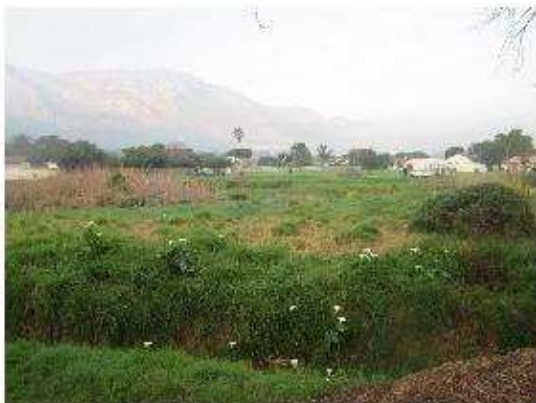
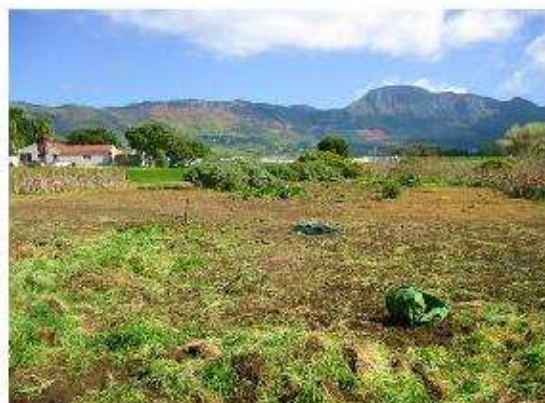
Figure 2. Kikuyu infested wetland before. Figure 3. Kikuyu infested wetland during.

2.Focus initial rehabilitation efforts on Paddavlei (point 1) by implementing interventions that does not require any Environmental Authorisations such as the removal of Alien invasive species (including kikuyu grass) and the removal of building rubble within the wetland. Refer to figure 1 to 3 for examples of successful removal of kikuyu and revegetation of a wetland within the City of Cape Town. This will minimise competition for indigenous vegetation to be re-established on the edge and within the limited buffer zone of the wetland. A written Rehabilitation plan with planned deliverables, time of the year for activities to take place and budget required will be a positive start to the project.

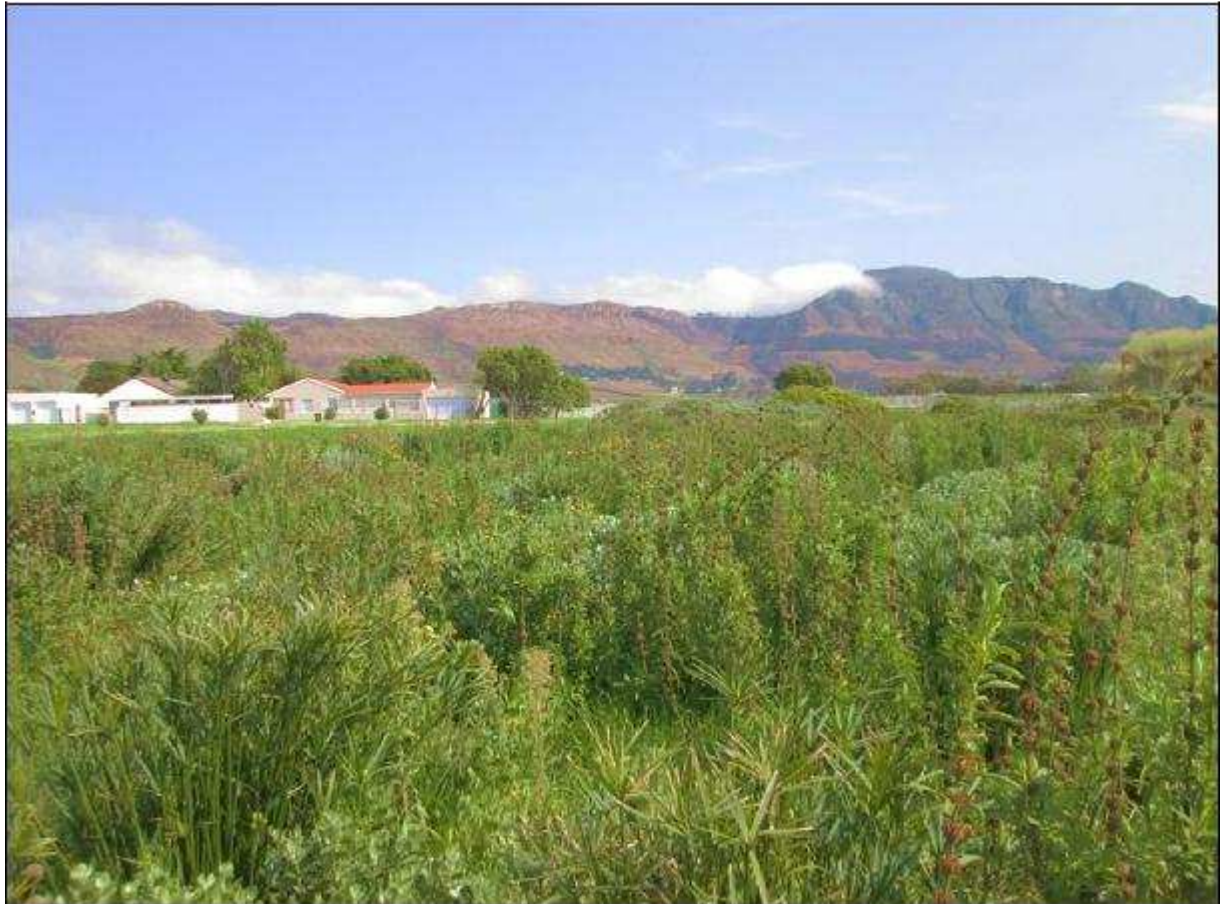
Figure 4. Kikuyu infested wetland after revegetation with indigenous wetland plants.
