Bot River Estuary Artificial Breaching Report

BREF MEETING 29 OCTOBER 2020

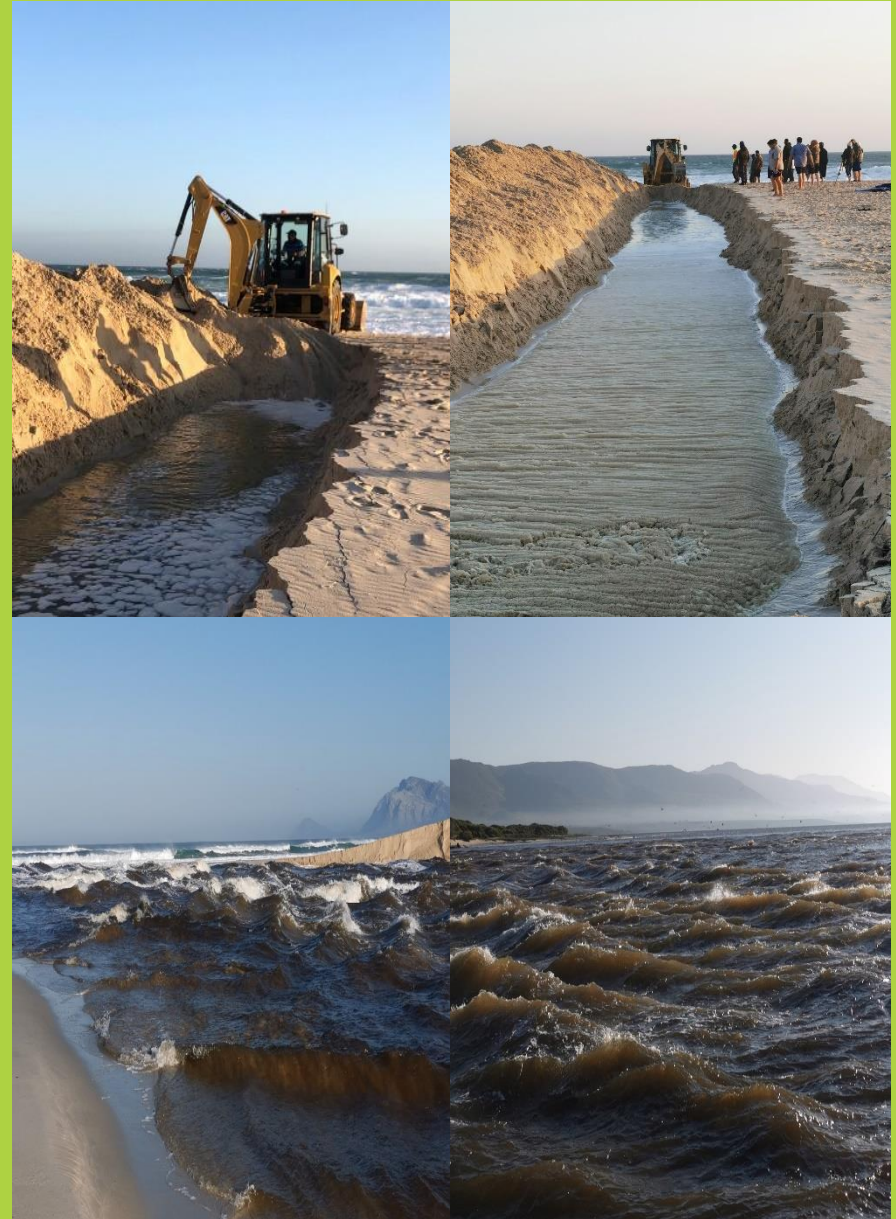
Artificial Breach of July 2020

- Bot river estuary was artificially breached on the 21st July 2020 after obtaining an emergency breach authorization directive
- In terms of Section 30A of The National Environmental Management Act 107 of 1998
- A 4m wide channel was excavated at $-34^{\circ}.3671$ E/ $19^{\circ}.0982$ S towards the sea.
- The excavation started at 14H00 and the estuary was breached at 18H20 resulting in an 80m wide channel during the night.

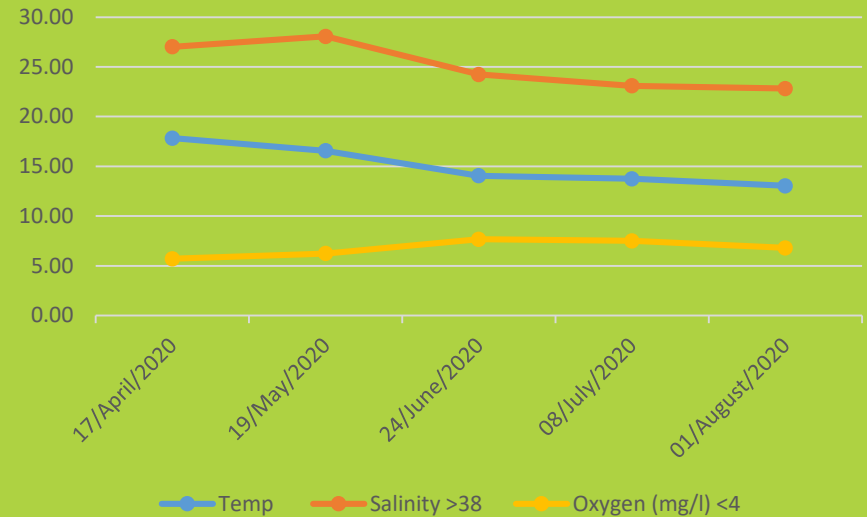
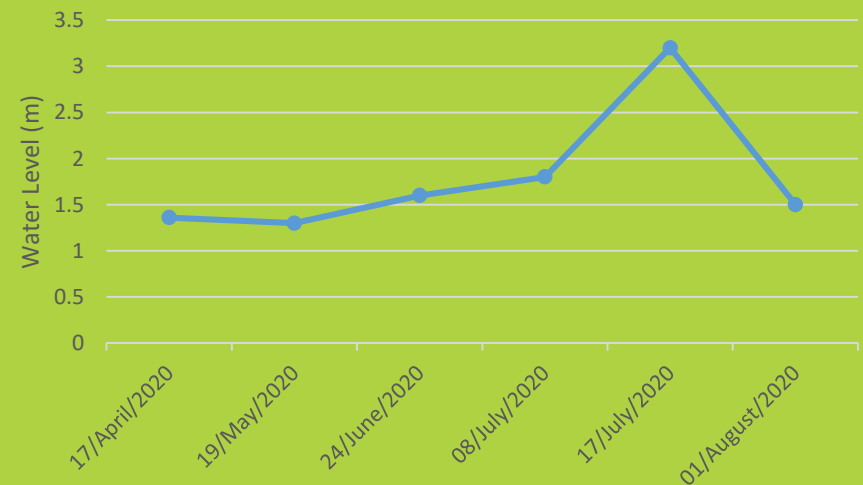
Estuary Conditions prior to breach

- Indicated an average salinity level of 23.09ppt, oxygen level of 7.50mg/l which was within the set thresholds of <4mg/l and >38ppt respectively
- The water level at the time of breaching was at 2.9m (msl)
- Sea conditions: NNW, <8m/s, SW swell off 2.2m with a low tide of 0,42m at 22H47

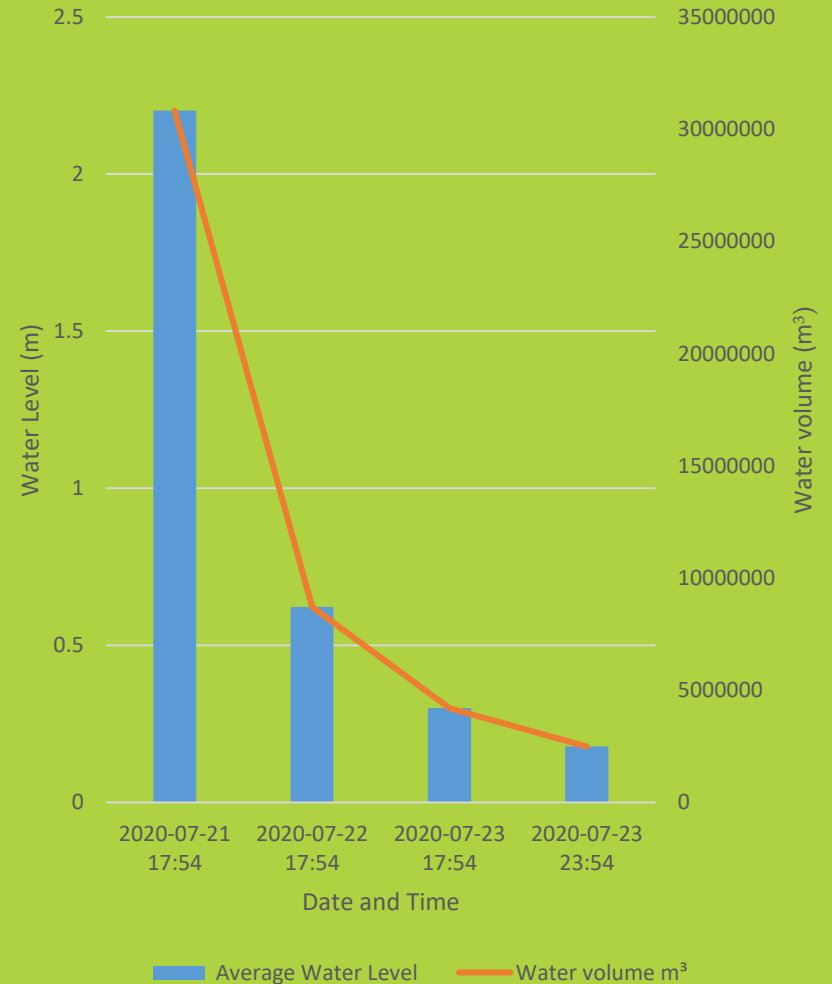
Water outflow rate

- A maximum outflow rate of a 255.96 m³/s occurred in the first 24 hours after breaching which is within the outflow level estimates of 254m³/s - 409m³/s (Fromme, 1985a).
- It is important to note that the estuary mouth at Kleinmond breached on the 17th July 2020 resulting in a decrease in water level of 0.38 cm which calculates to a approximate loss of 5338000 m³ of water

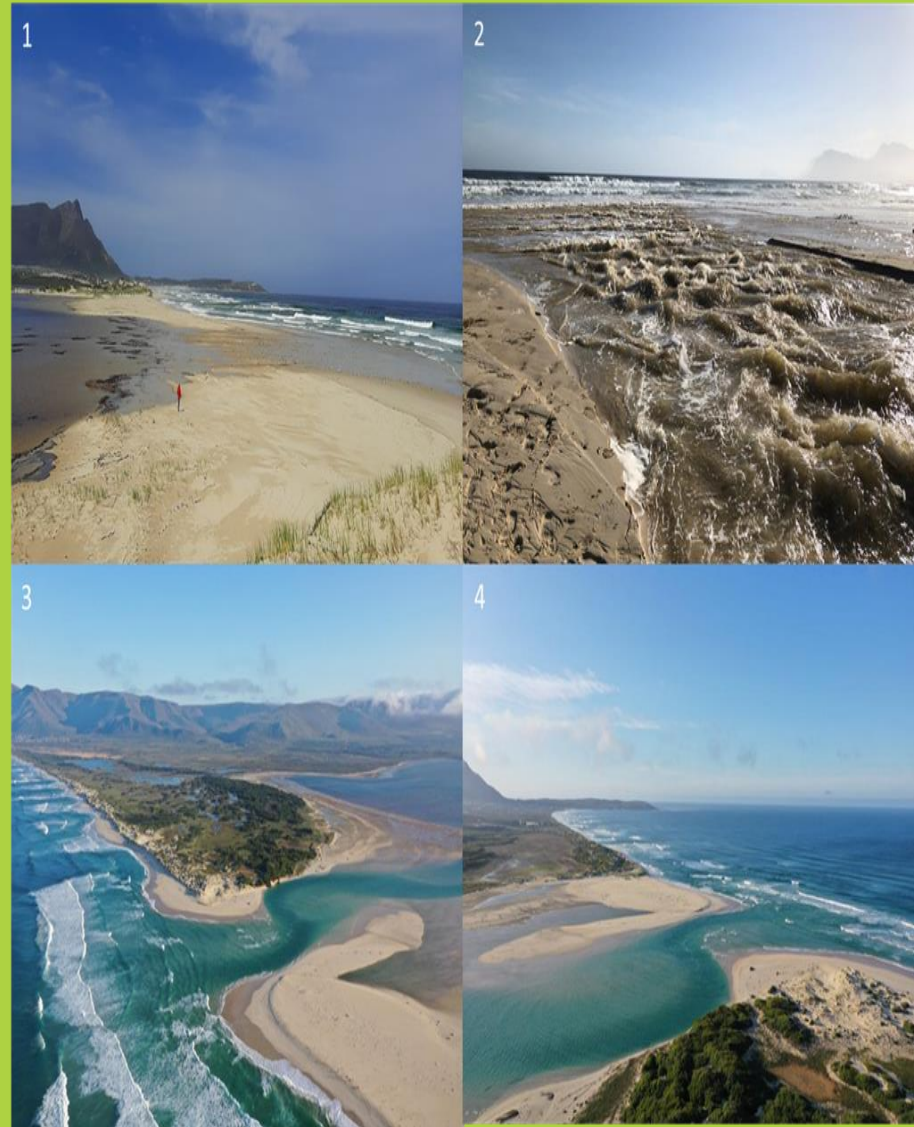
Estuary Conditions after artificial breach

- Mouth closed on the 13th of August 2020 due to severe sea conditions depositing sand onto the berm at the mouth. The mouth remained closed up to the 2nd of September 2020.
- A natural breach occurred on the 3rd of September 2020 due to good freshwater inflow from the catchment. The mouth remains open with noticeable seawater inflow into the estuary

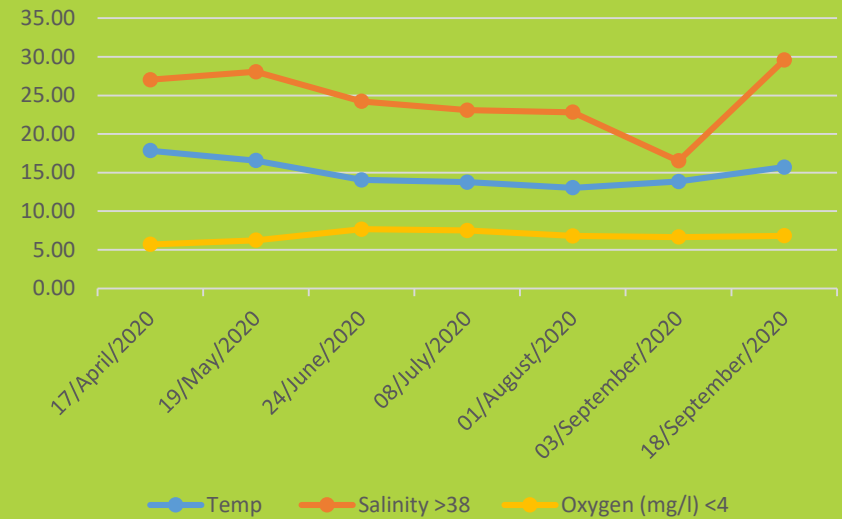
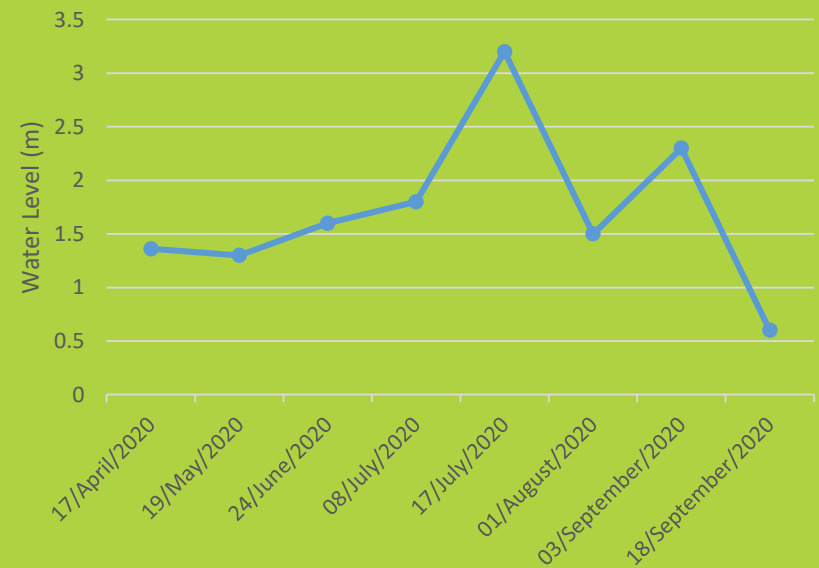
Estuary Conditions prior to and after natural breach

- Depicted and average salinity level of 16.52ppt, oxygen level of 6.65ml/g which was within the set thresholds
- Water level 2.3m

- Average, salinity level of 29.57ppt, oxygen level of 6.82ml/g.
- Water level of 0.60m.

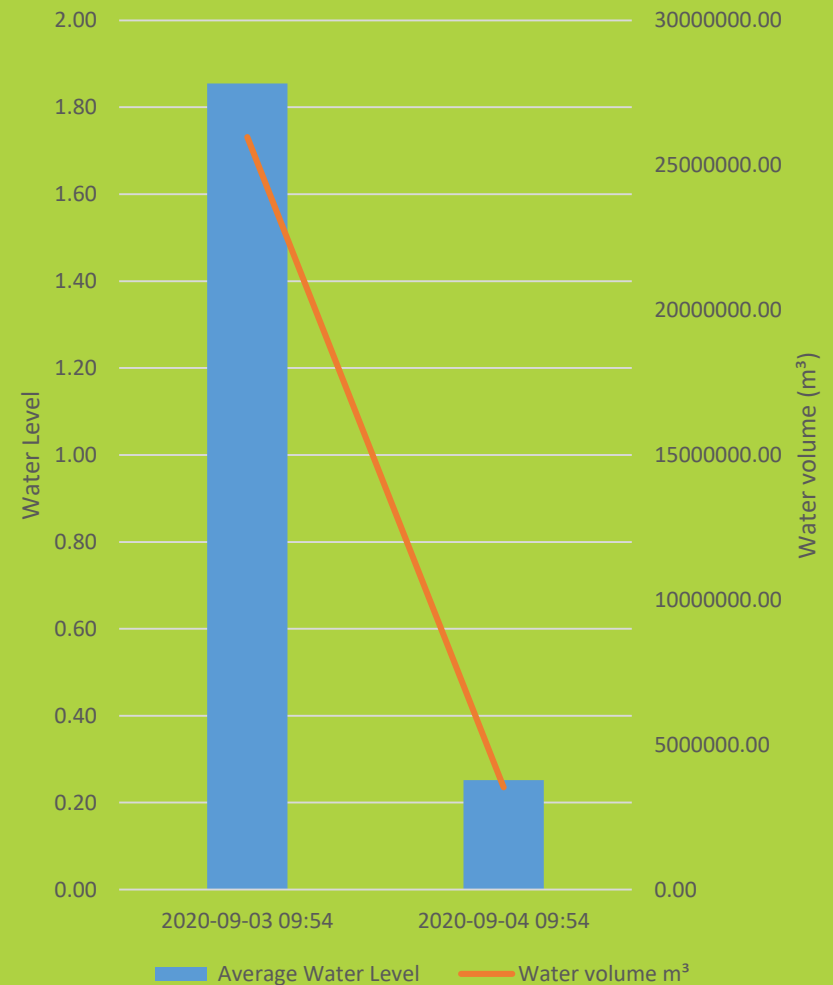
Water outflow rate natural breach

- A maximum out flow rate of $259.74\text{m}^3/\text{s}$ occurred in the first 24 hours after the natural breaching

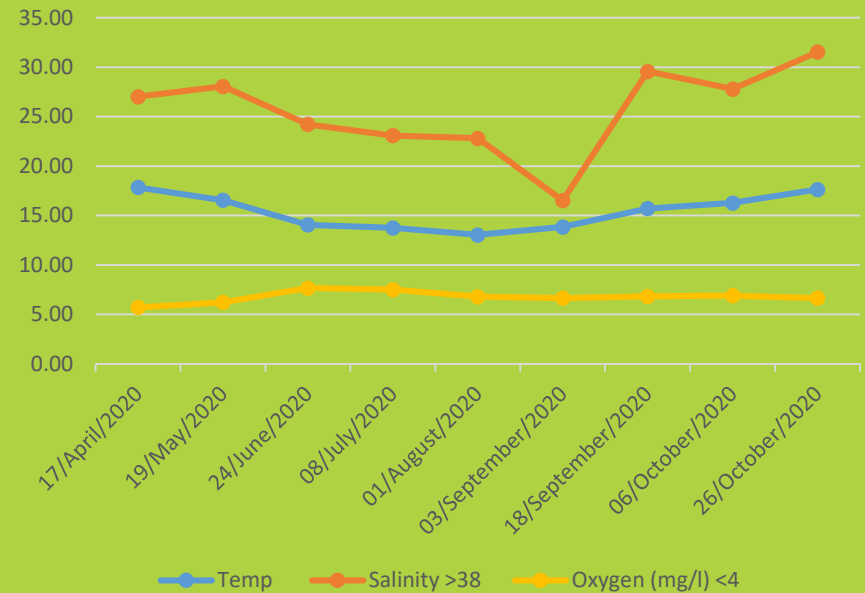
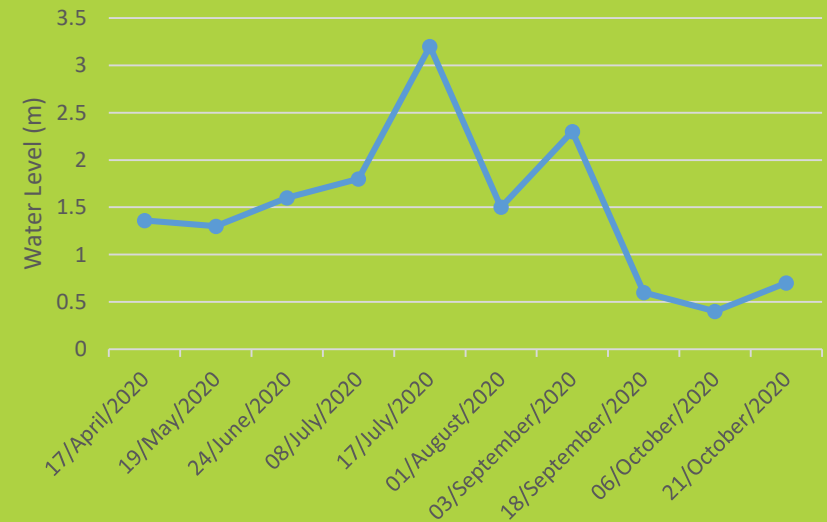
Current Estuary Conditions

- Depicted and average salinity level of 31.54ppt, oxygen level of 6.65 ml/g
- Water level 0.7m
- Mouth Condition: Open
